Interim Report

WATERSHED RESTORATION PROGRAM

MISSION CREEK STREAM ASSESSMENT

Project 511.01

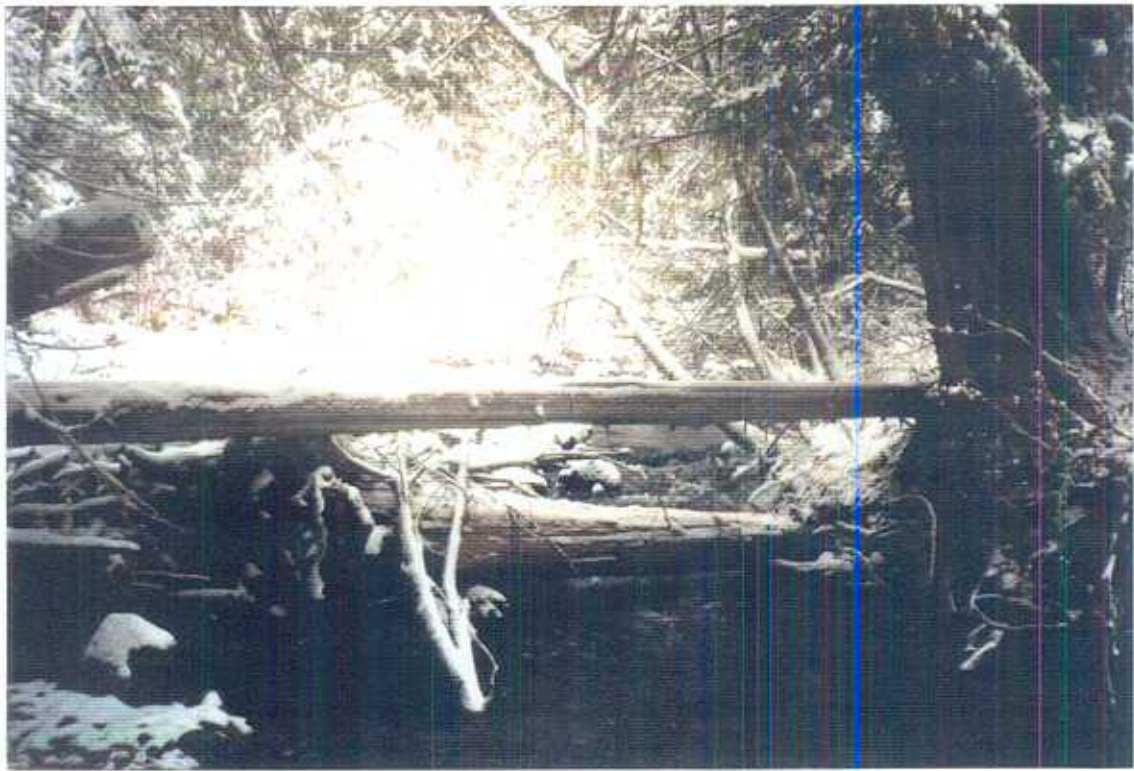
Photo 1. Natural LWD across the channel, upstream view.
Stream Name: Belgo Creek **Site #:** 4
GPS Coordinates: 49°??'??N 119°08'65W

Reach #: 1
Code: Fb/Q·D·N·3

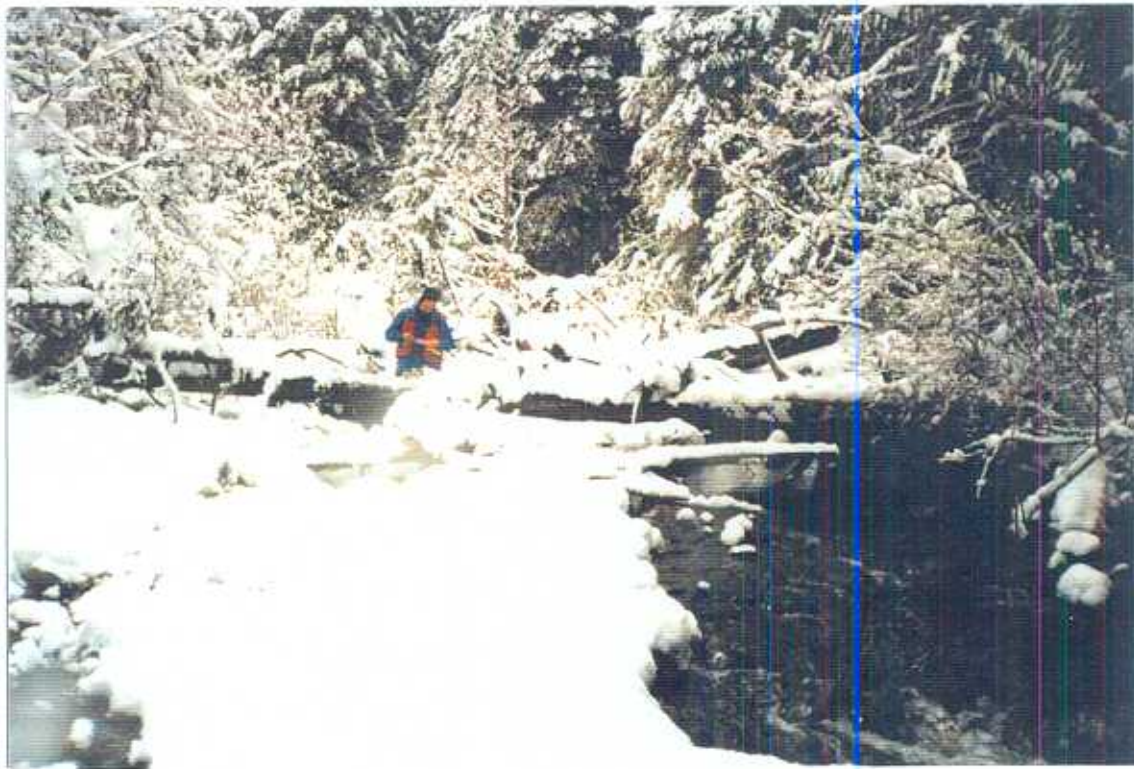
Photo 2. Natural LWD across the channel stranded on a gravel bar, upstream view.
Stream Name: Belgo Creek **Site #:** 4
GPS Coordinates: 49°??'??N 119°08'65W

Reach #: 1
Code: Fb/Q·D·N·3

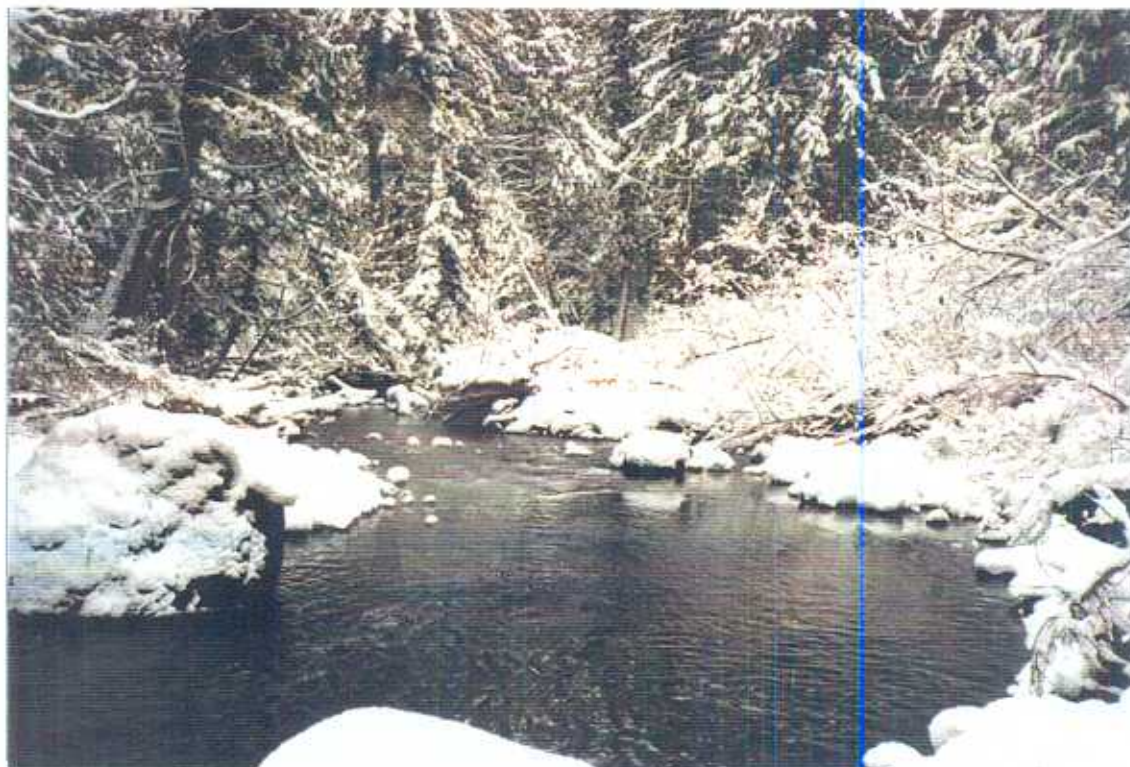
Photo 3. Undercut banks and overhanging vegetation, downstream view.
Stream Name: Belgo Creek Site #: 4 Reach #: 1
GPS Coordinates: 49°??'??N 119°08'65W Code: N/A

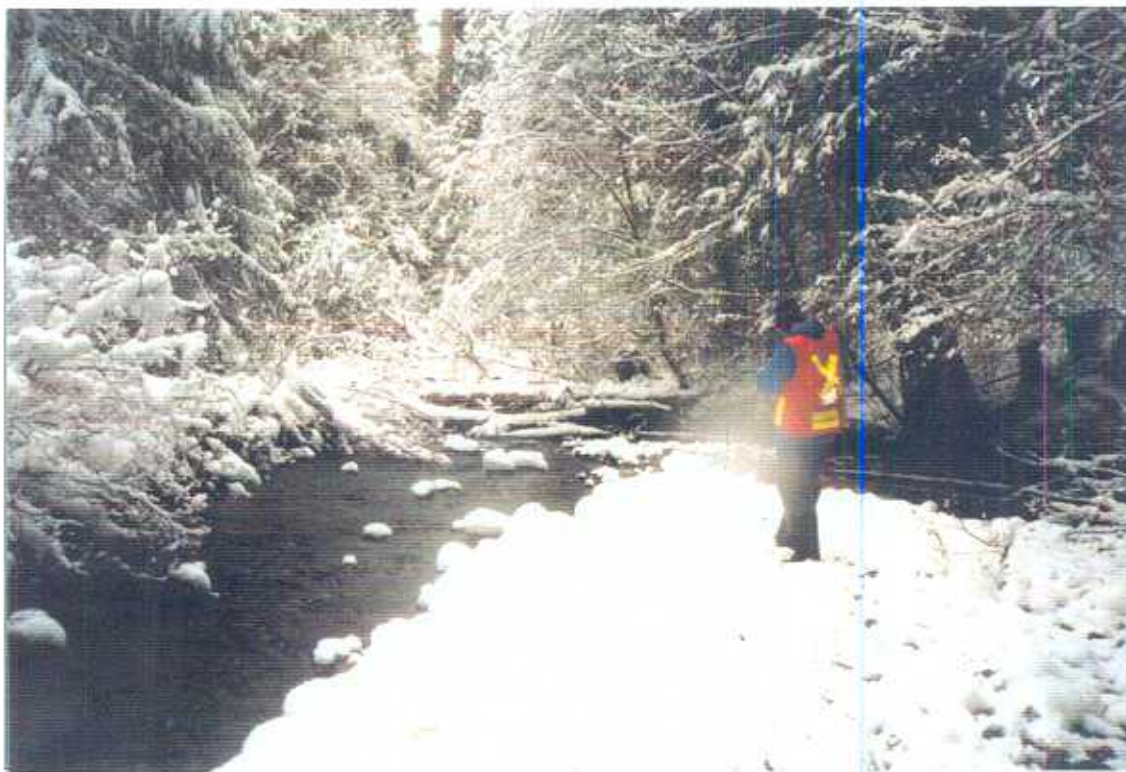
Photo 4. Old debris jam which has had some pieces cut and removed, downstream view.
Stream Name: Belgo Creek Site #: 4 Reach #: 1
GPS Coordinates: 49°??'??N 119°08'65W Code: Fb/Q•D•N•3

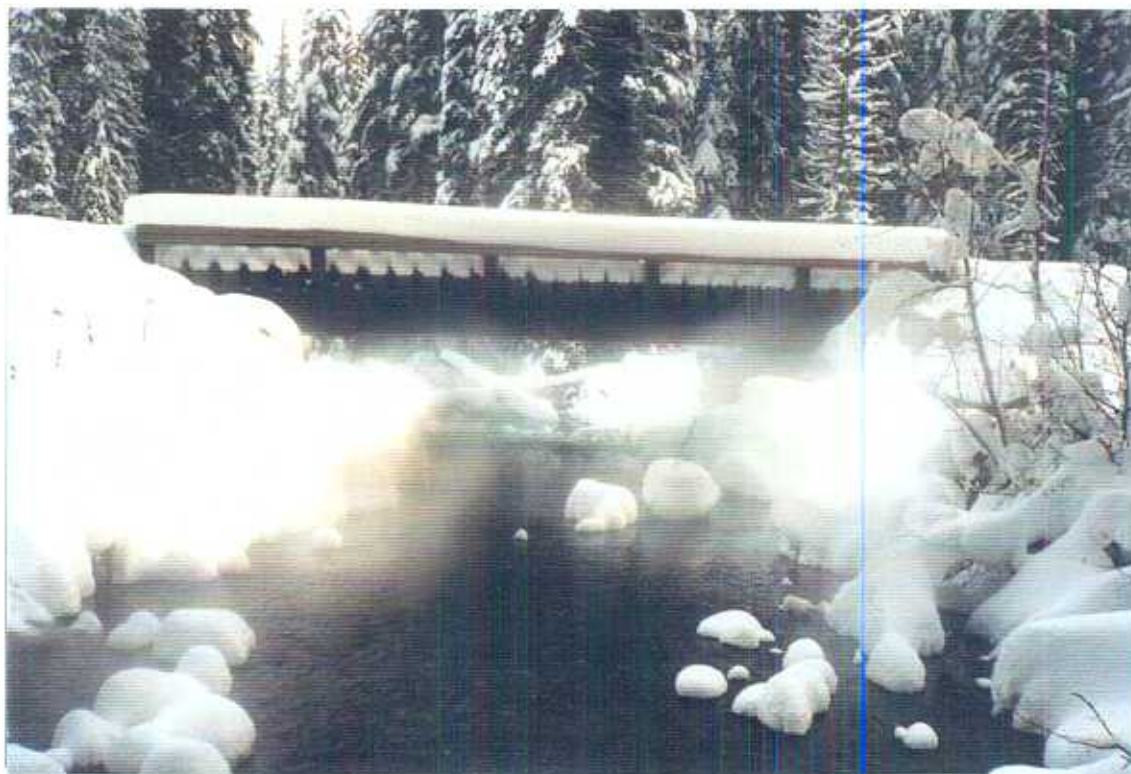
Photo 5. Bridge crossing with sufficient vertical & horizontal clearance, downstream view.
Stream Name: Belgo Creek **Site #:** 20 **Reach #:** 3
GPS Coordinates: 49°??'??N 119°04'36W **Code:** Q-C-F-3

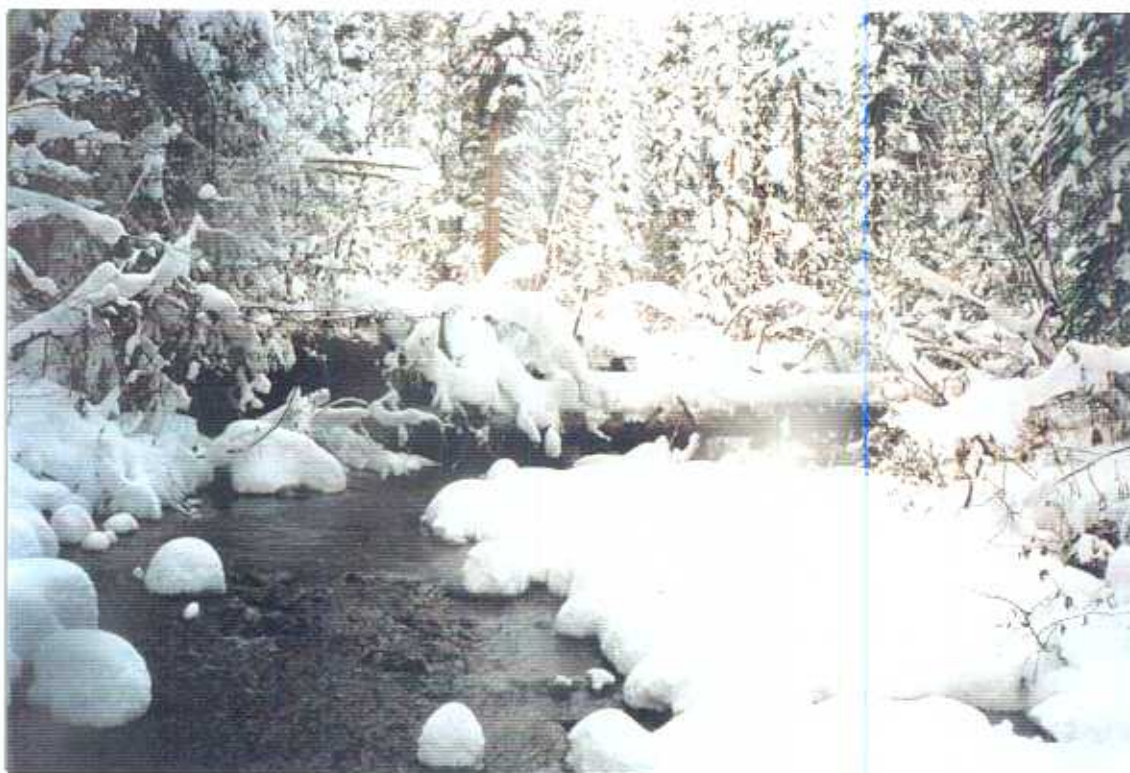
Photo 6. Natural debris jam 50m u/s from the bridge crossing, upstream view.
Stream Name: Belgo Creek **Site #:** 20 **Reach #:** 3
GPS Coordinates: 49°??'??N 119°04'36W **Code:** Fb/Q-D-N-2

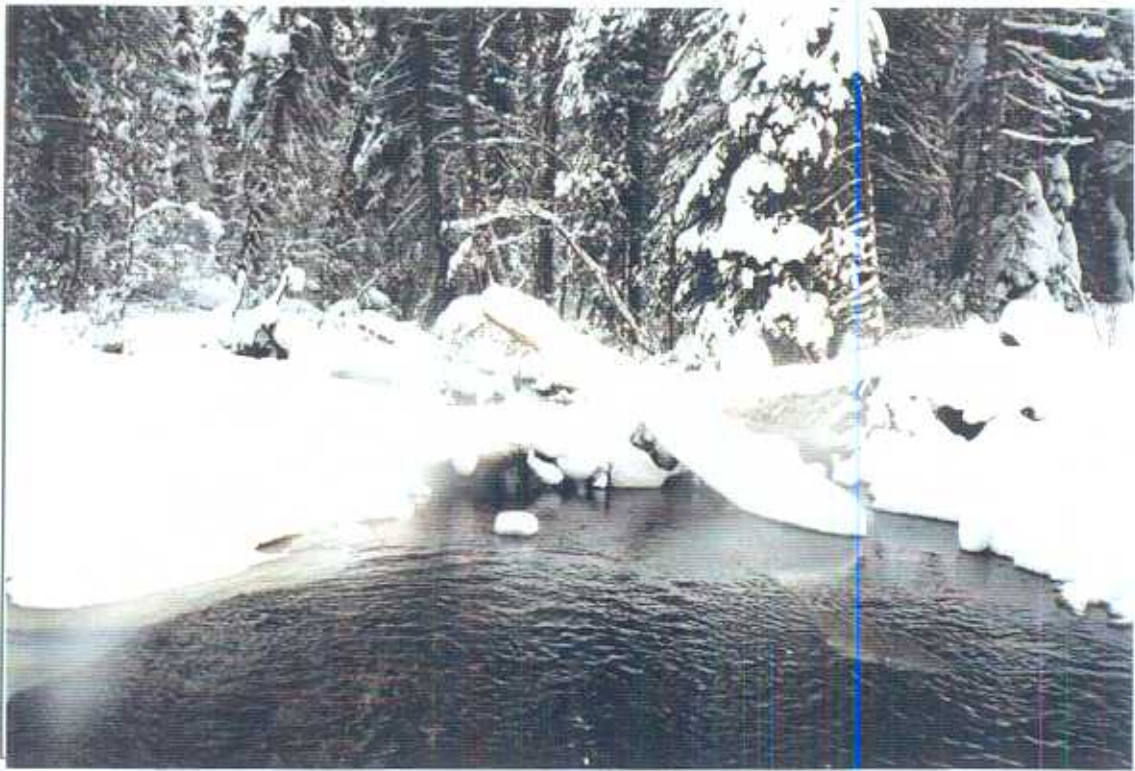
Photo 7. Natural debris jam 20m d/s from the bridge crossing, downstream view.
Stream Name: Belgo Creek **Site #:** 20 **Reach #:** 3
GPS Coordinates: 49°??'??N 119°04'36W **Code:** Fb/Q•D•N•2

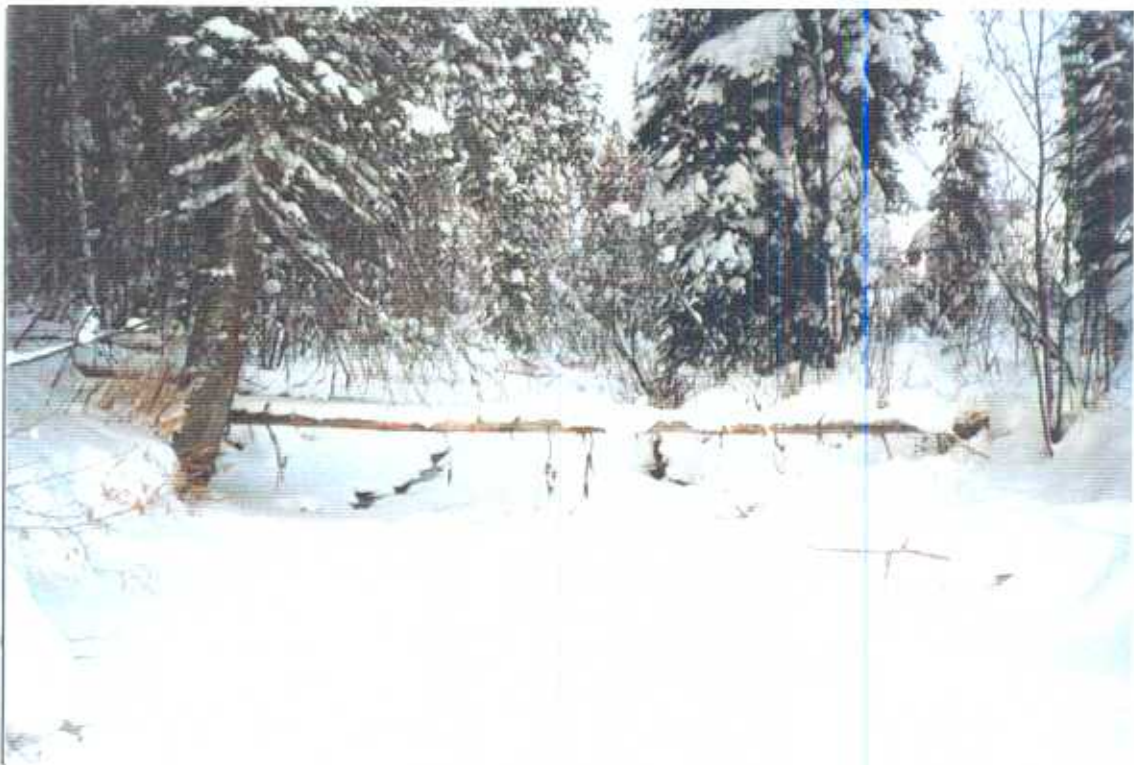
Photo 8. Natural LWD across the channel with a 5m buffer on the left bank, upstream view.
Stream Name: Belgo Creek **Site #:** 23 **Reach #:** 3
GPS Coordinates: 49°??'??N 119°04'46W **Code:** N/A

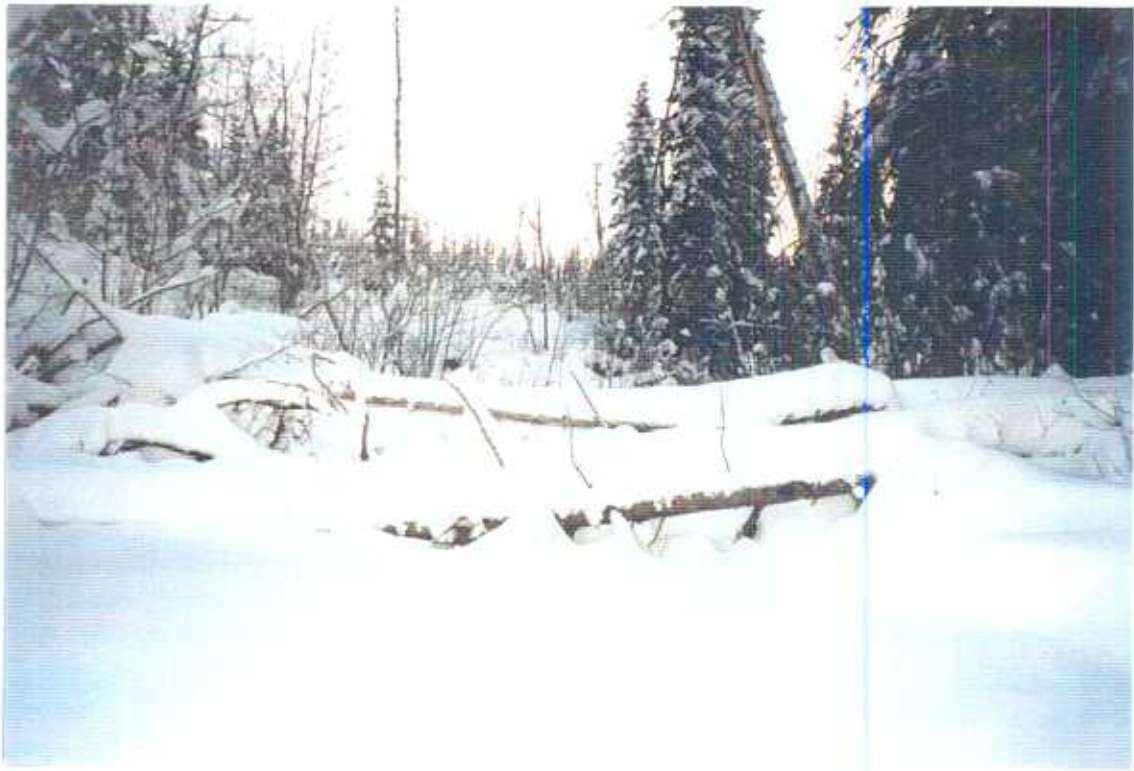
Photo 9.

Natural LWD across the channel, downstream view.

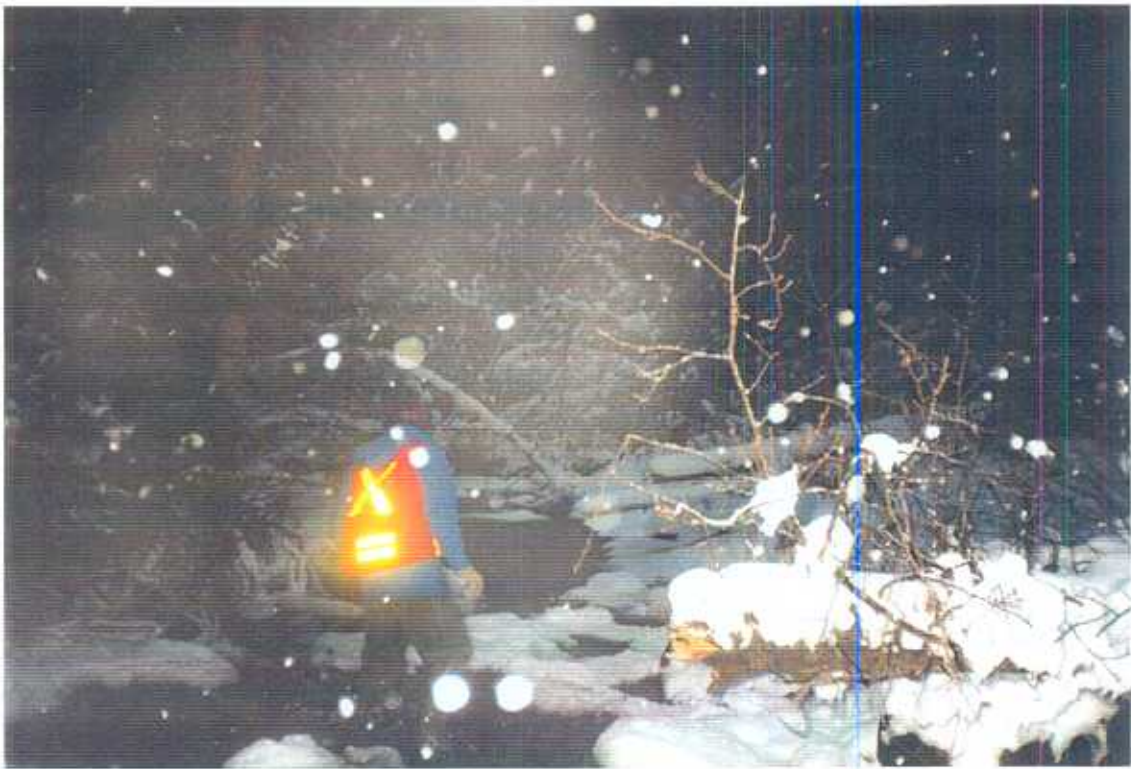
Photo 1. Main channel opposite the slide (no impact on the stream) from the road, downstream view.

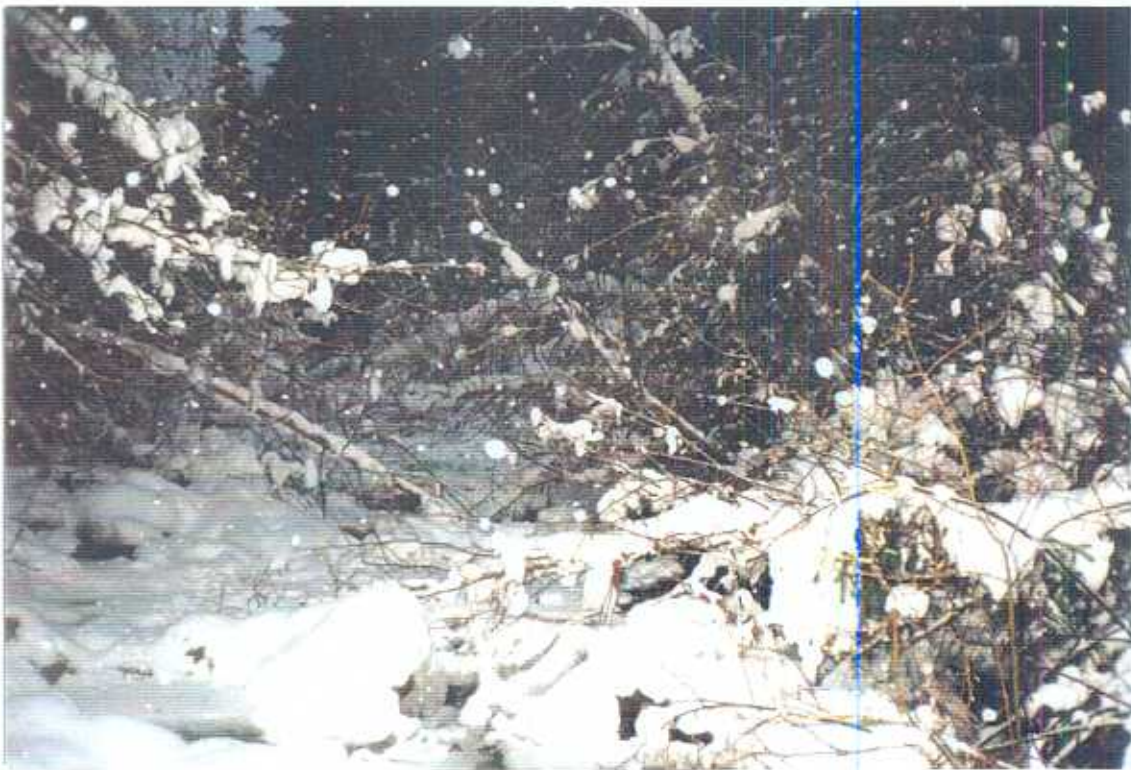
Photo 2. Main channel opposite the slide (no impact on the stream) from the road, upstream view.

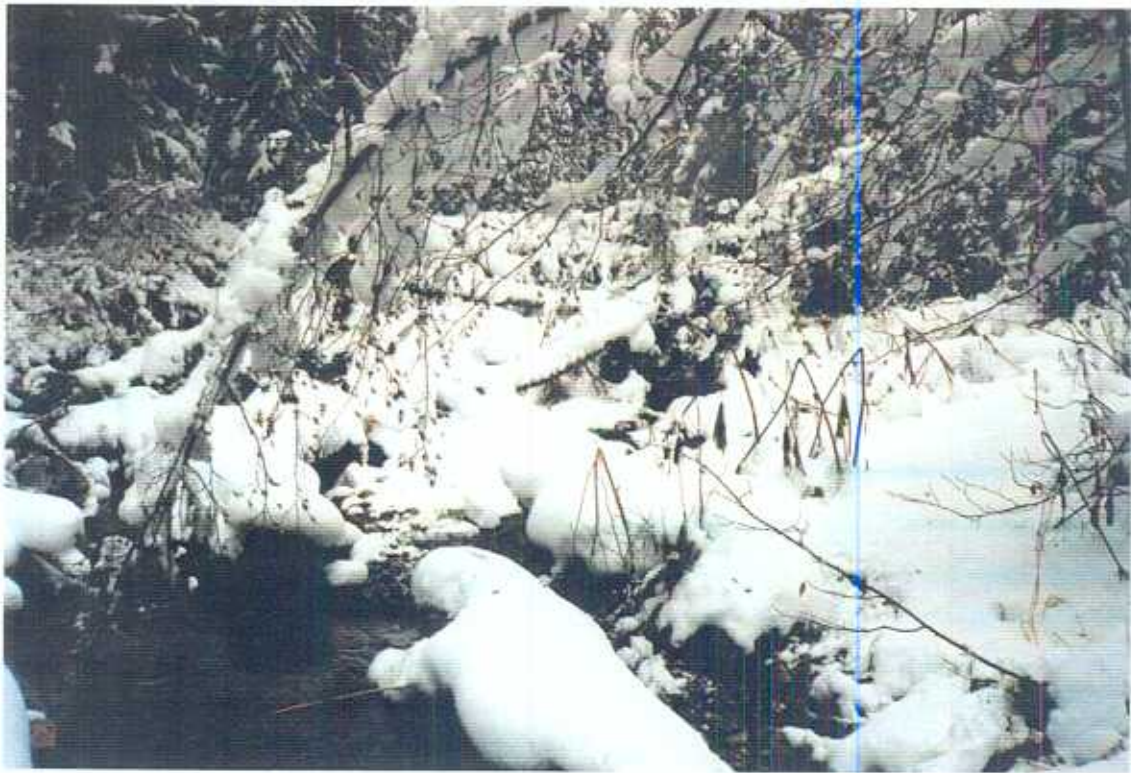
Photo 1. LWD blocking the channel from the slide on the right bank, downstream view.
Stream Name: Joe Rich Creek **Site #:** 7 **Reach #:** 2
GPS Coordinates: 49°48'48N 119°04'92W **Code:** Fb/Q•D•F•1

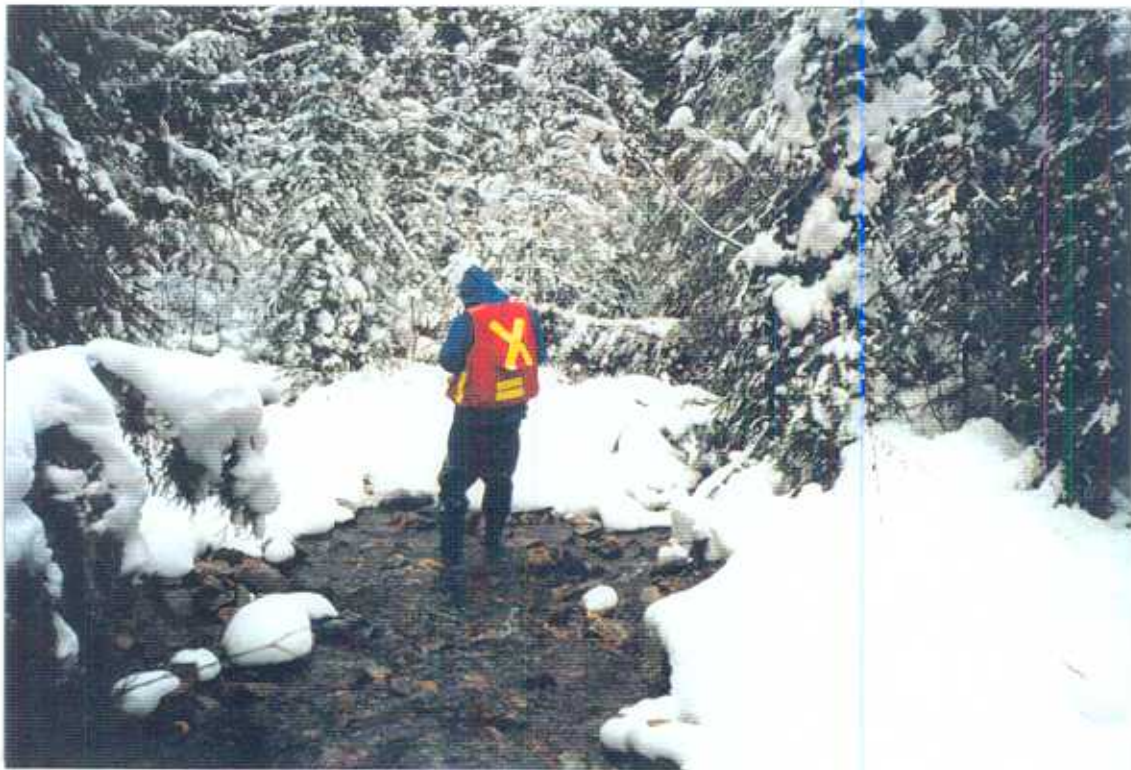
Photo 2. 20m d/s from the slide on the right bank, downstream view.
Stream Name: Joe Rich Creek **Site #:** 7 **Reach #:** 2
GPS Coordinates: 49°48'48N 119°04'92W **Code:** N/A

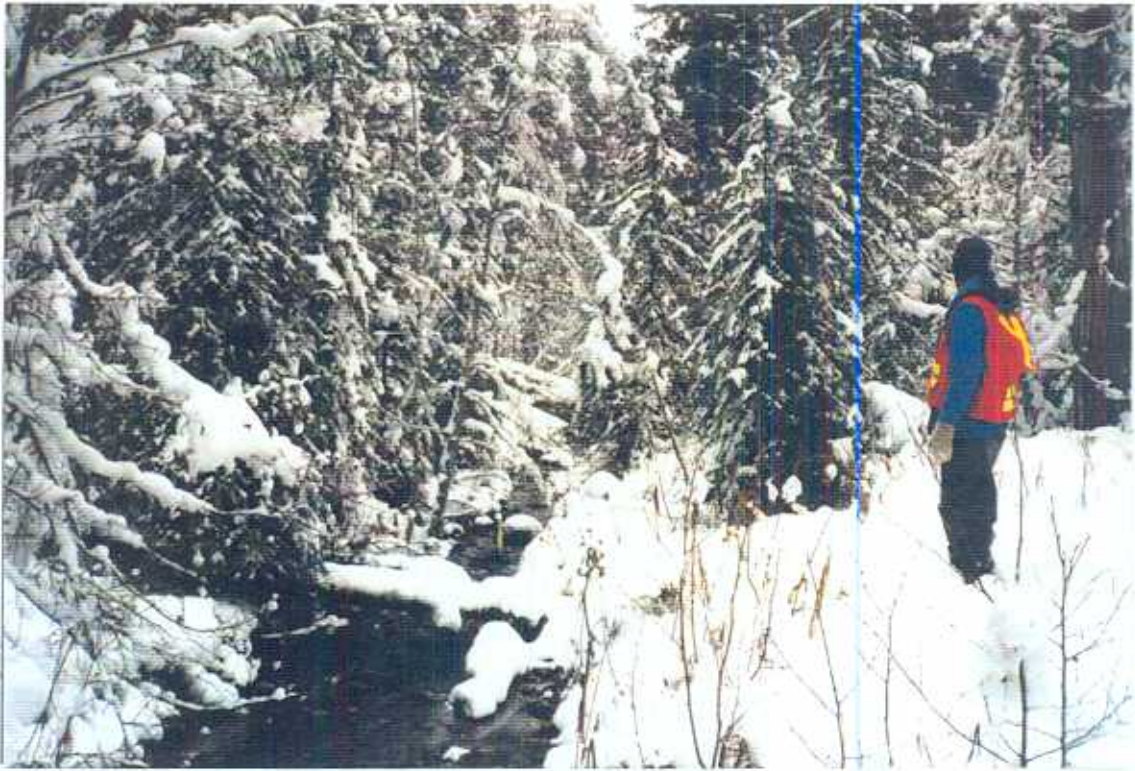
Photo 3. Just u/s from the slide on the right bank, upstream view.

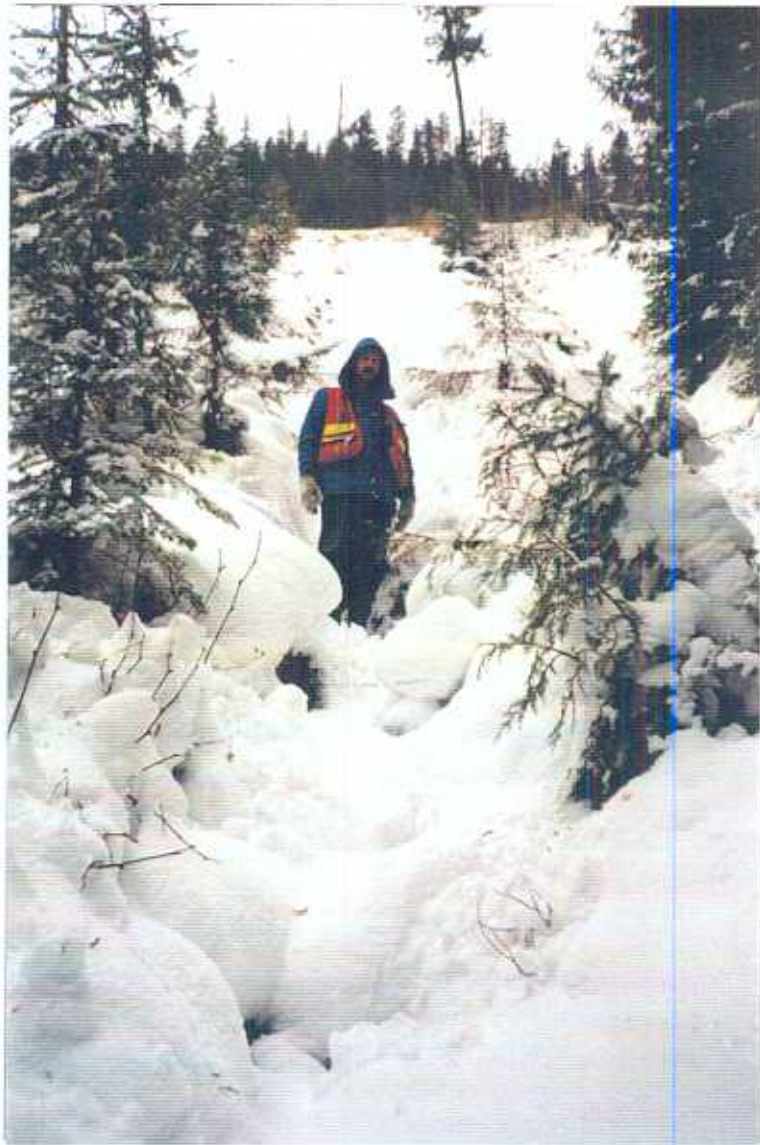
Photo 4.

Highway road-fill material actively eroding (rills 1-2m deep) onto the floodplain and into the channel on the left bank of the stream.

Code: Q•F•Hw•2

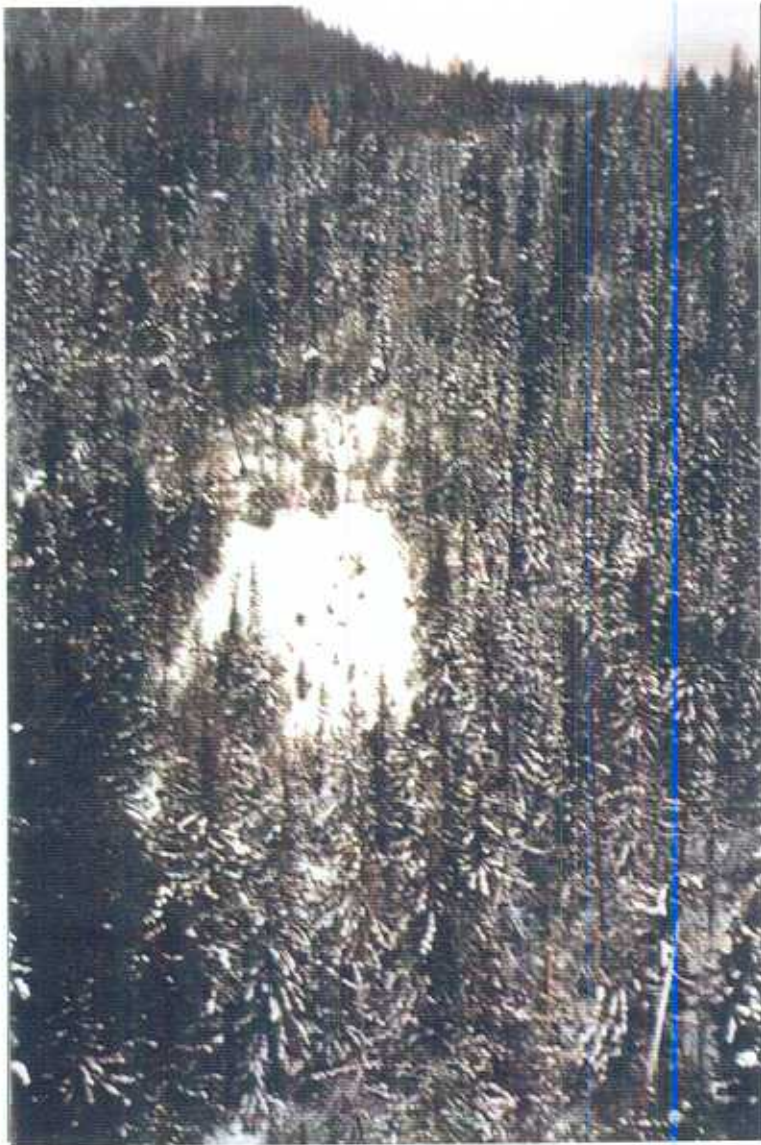
Photo 5.

Slide on the right bank of the stream as seen from the highway.

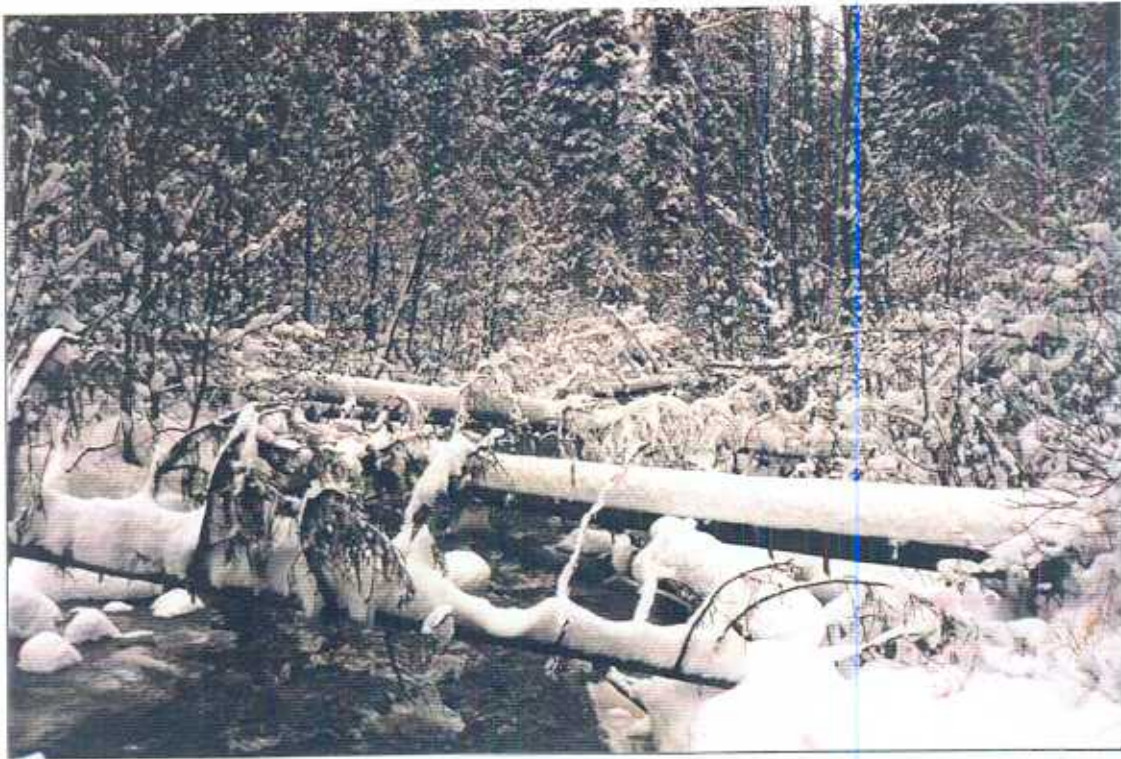
Photo 1.

Natural LWD across the stream just d/s from the SW block boundary, downstream view.

Code: Fb/Q•D•N•3

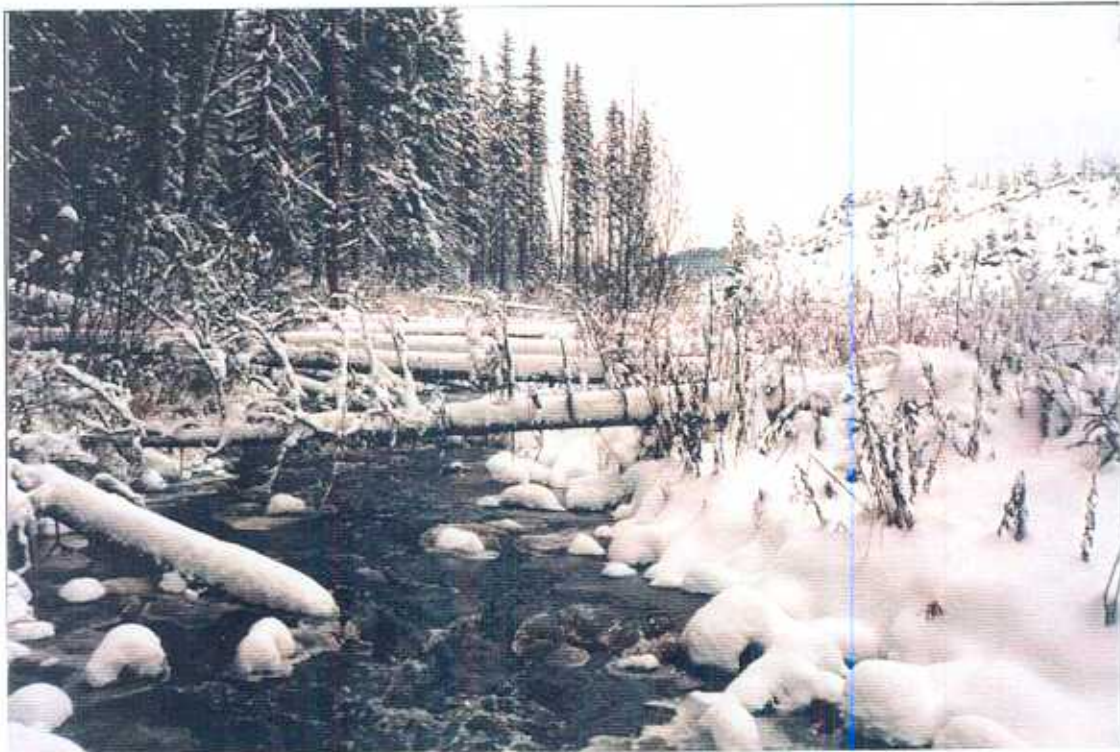
Photo 2.

Windfall, from within the block, across the stream just u/s from the SW block boundary, upstream view.

Code: Fb/Q•D•F•1

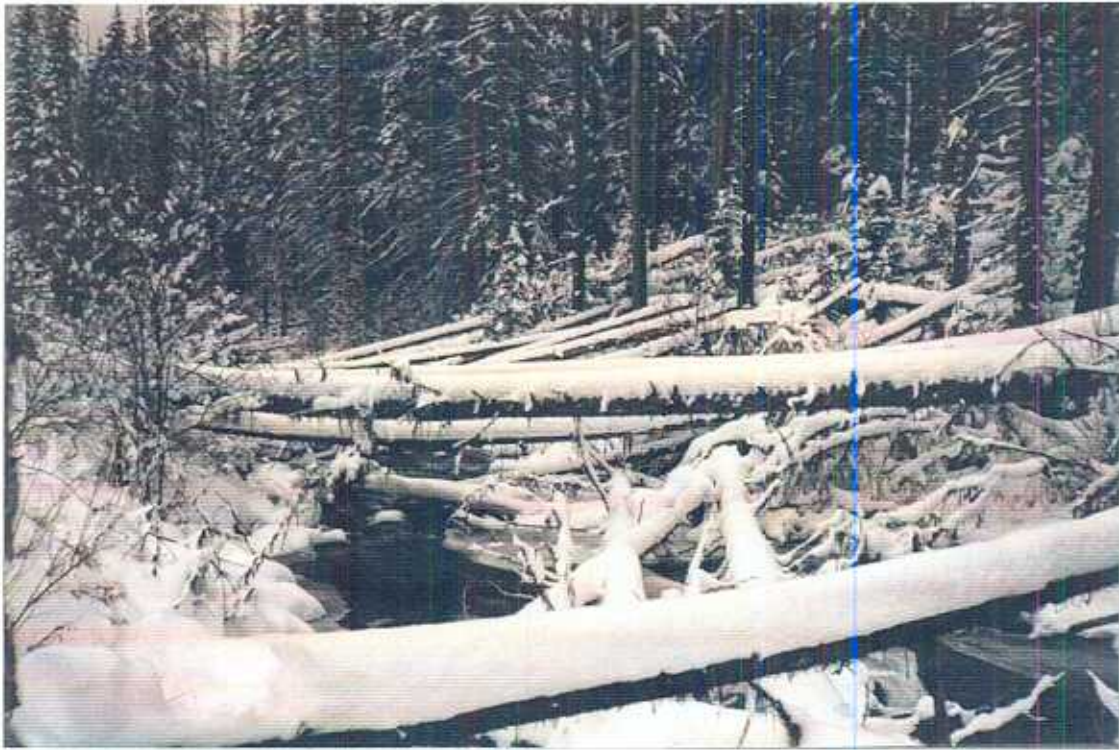
Photo 3. Windfall continuing u/s for virtually the entire length of the block, downstream view.
Stream Name: Hydraulic Creek **Site #:** 15 **Reach #:** 4
GPS Coordinates: 49°48'73N 119°13'12W **Code:** Fb/Q•D•F•1

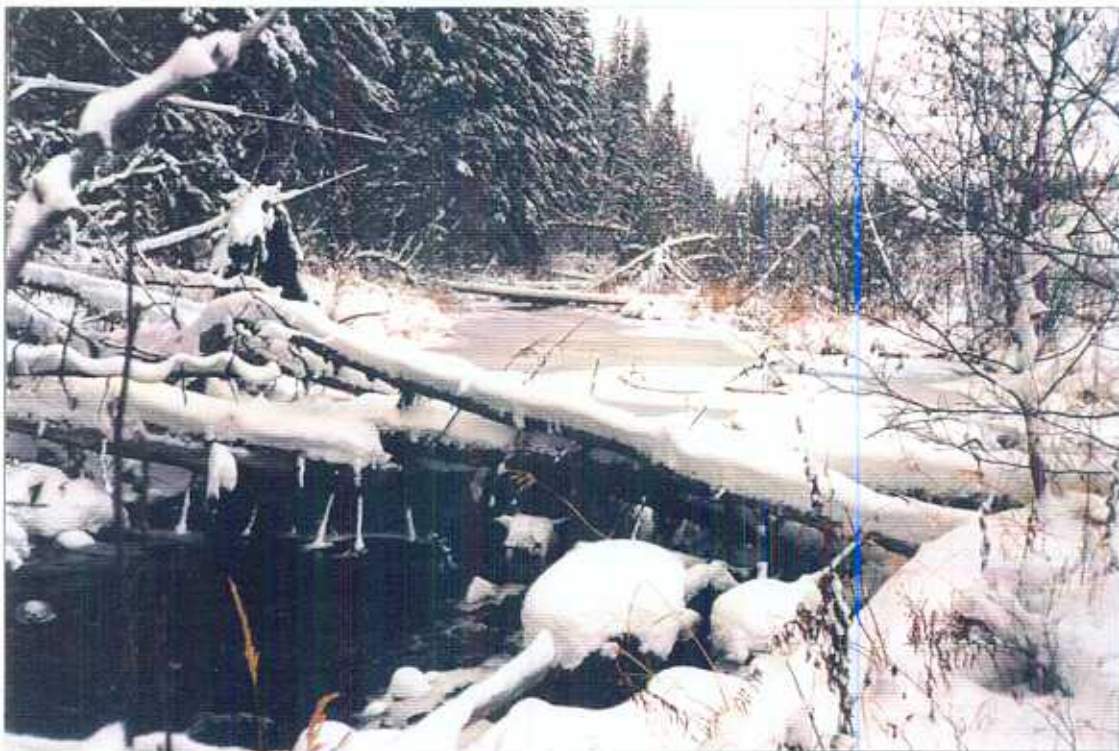
Photo 4. Debris jam (1m high) 500m u/s from the SW block boundary, upstream view.
Stream Name: Hydraulic Creek **Site #:** 15/16 **Reach #:** 4
GPS Coordinates: 49°48'08N 119°12'52W **Code:** Fb/Q•D•F•1

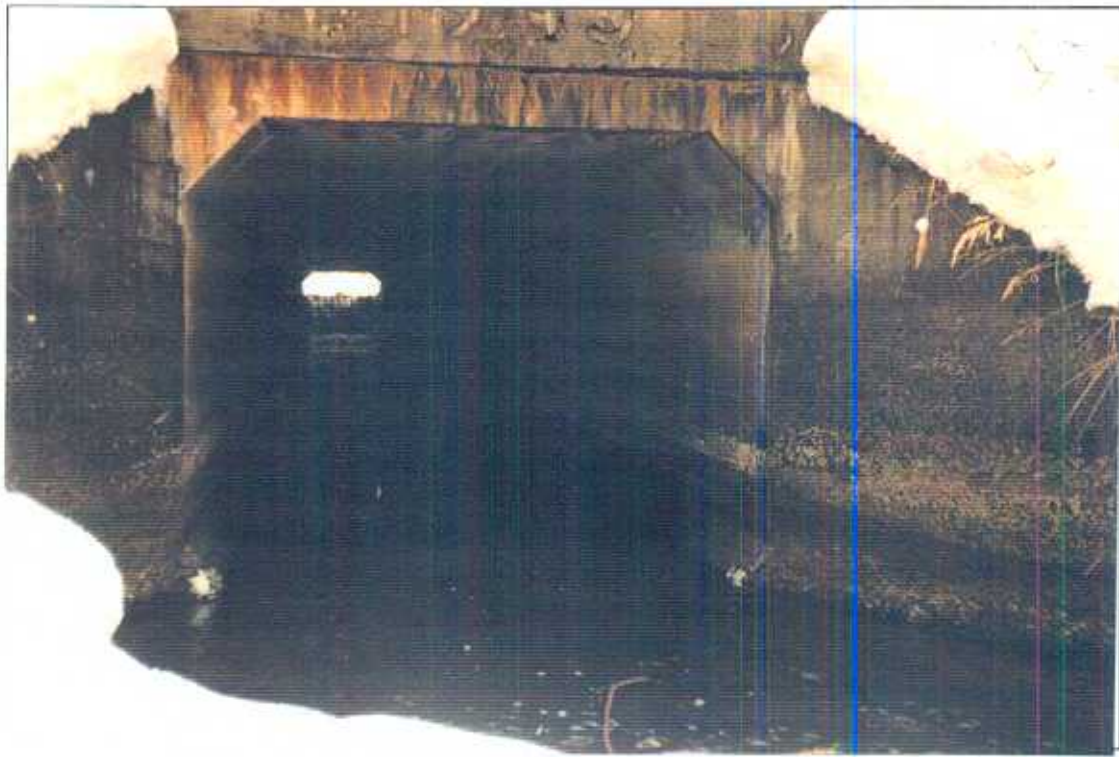
Photo 7. Concrete culvert (1.25m diam.) under the old railway bed of the KVR, upstream view.
Stream Name: Hydraulic Creek **Site #:** 18 **Reach #:** 4
GPS Coordinates: 49°47'75N 119°12'04W **Code:** N/A

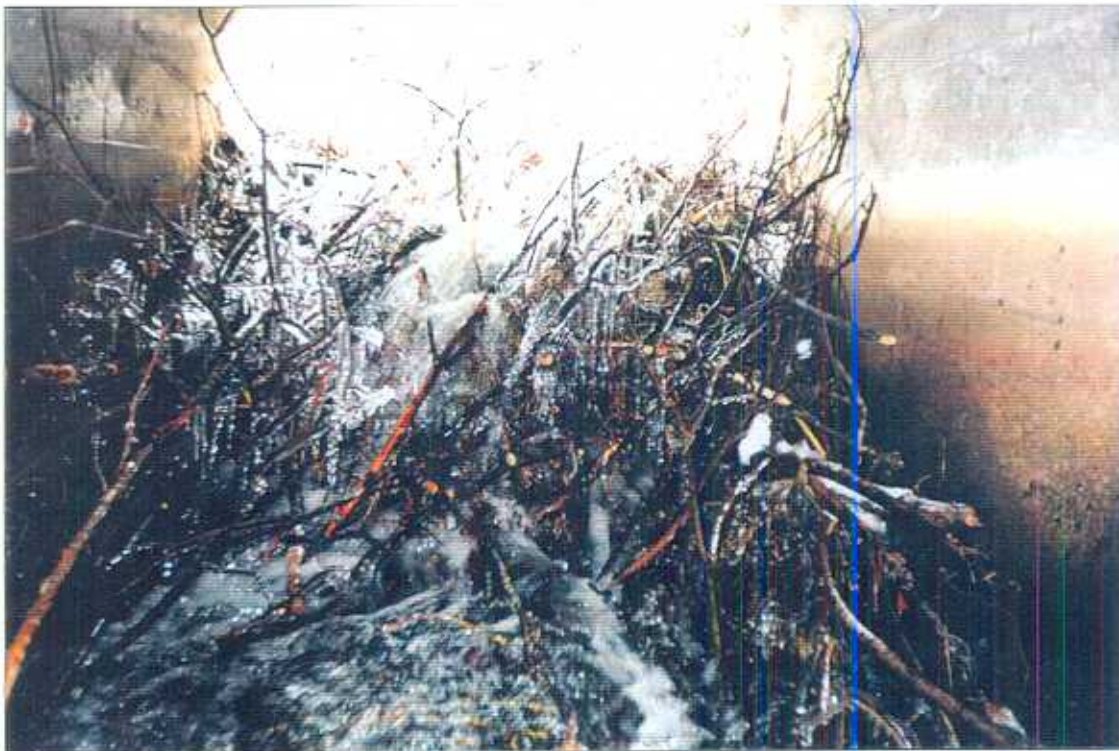
Photo 8. Beaver dam partially blocking the upstream end of the culvert, upstream view from within the culvert.
Stream Name: Hydraulic Creek **Site #:** 18 **Reach #:** 4
GPS Coordinates: 49°47'75N 119°12'04W **Code:** Fb•D•N•2

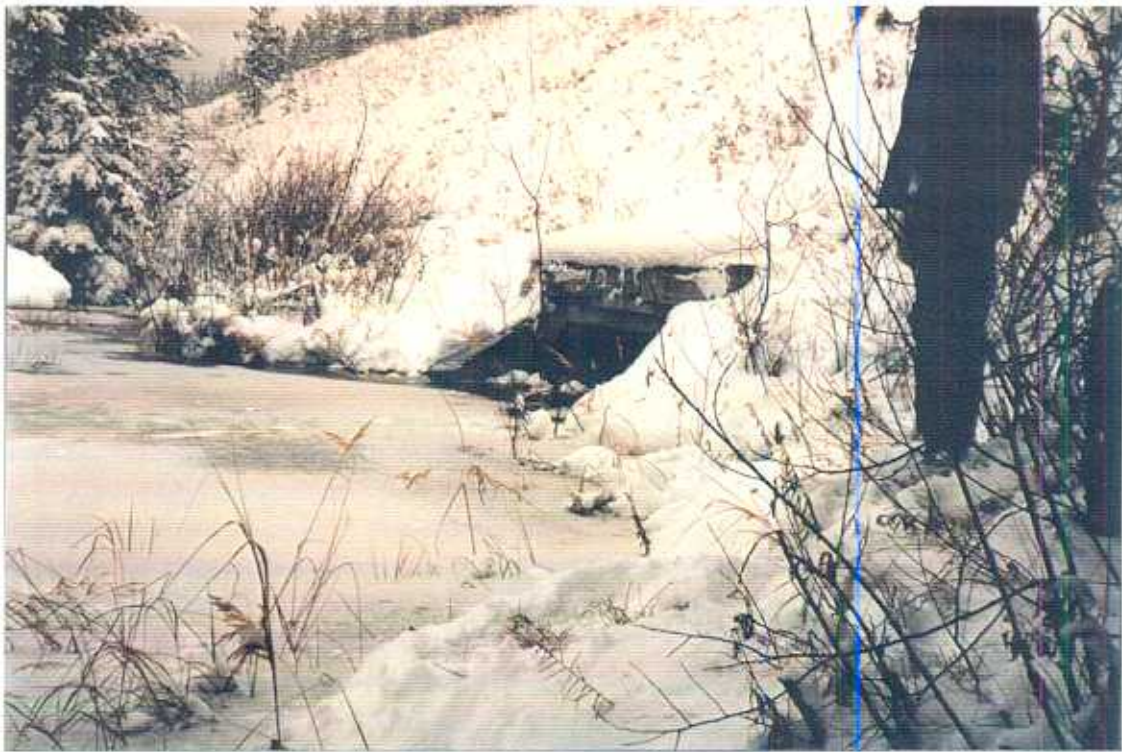
Photo 9. U/S end of the culvert showing 40cm opening remaining, downstream view.
Stream Name: Hydraulic Creek **Site #:** 18 **Reach #:** 4
GPS Coordinates: 49°47'75N 119°12'04W **Code:** Fb•D•N•2

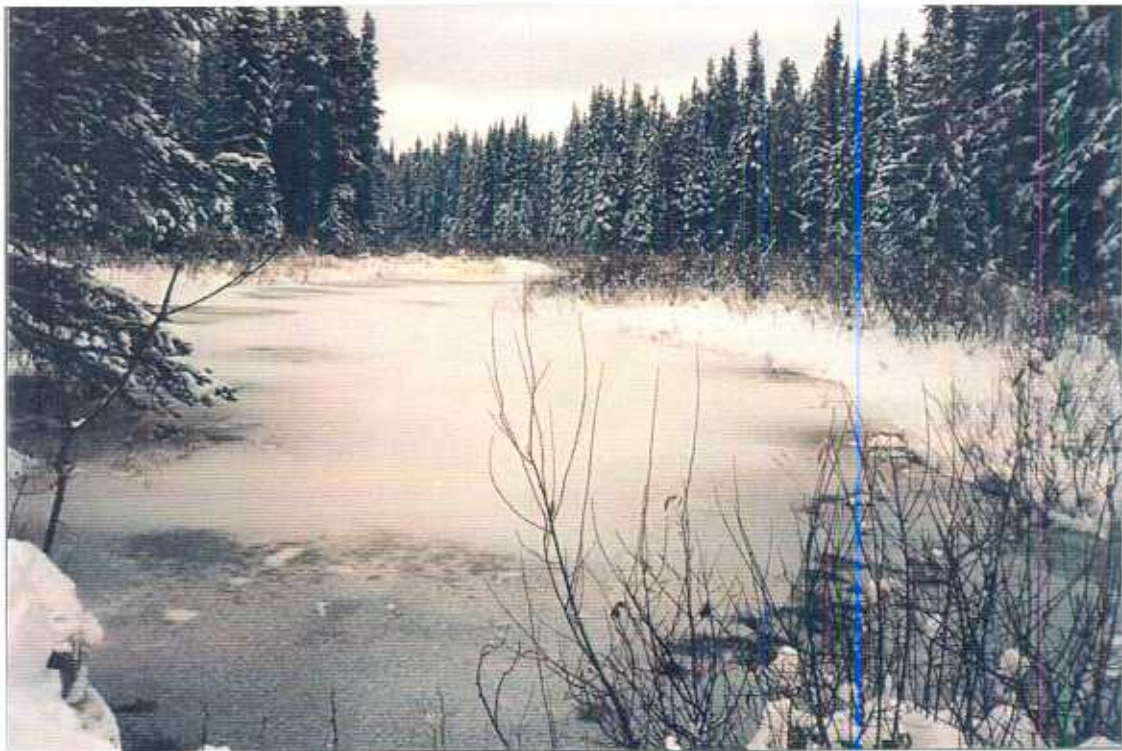
Photo 10. Beaver pond created by the dam at the culvert, upstream view.
Stream Name: Hydraulic Creek **Site #:** 18 **Reach #:** 4
GPS Coordinates: 49°47'75N 119°12'04W **Code:** N/A

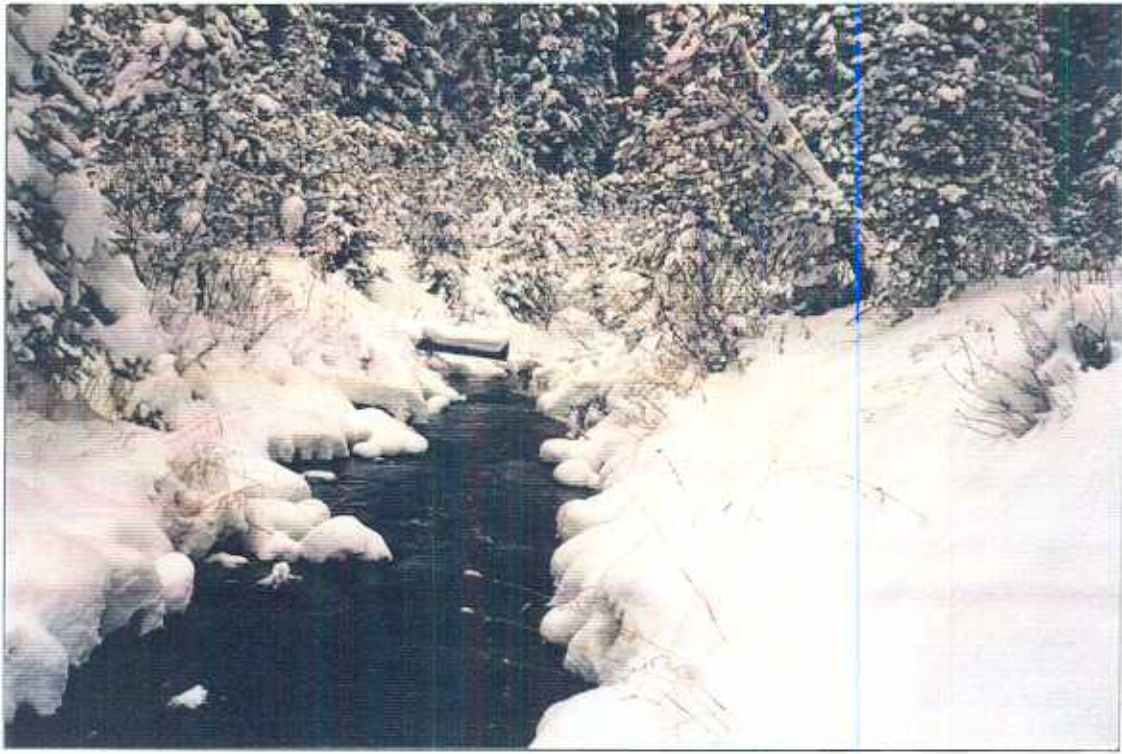
Photo 11. Steel drain pipe (25cm diam.) entering the channel on the left bank 20m d/s from the culvert, downstream view.
