Interim Report

WATERSHED RESTORATION PROGRAM

MISSION CREEK STREAM ASSESSMENT

Project 511.01

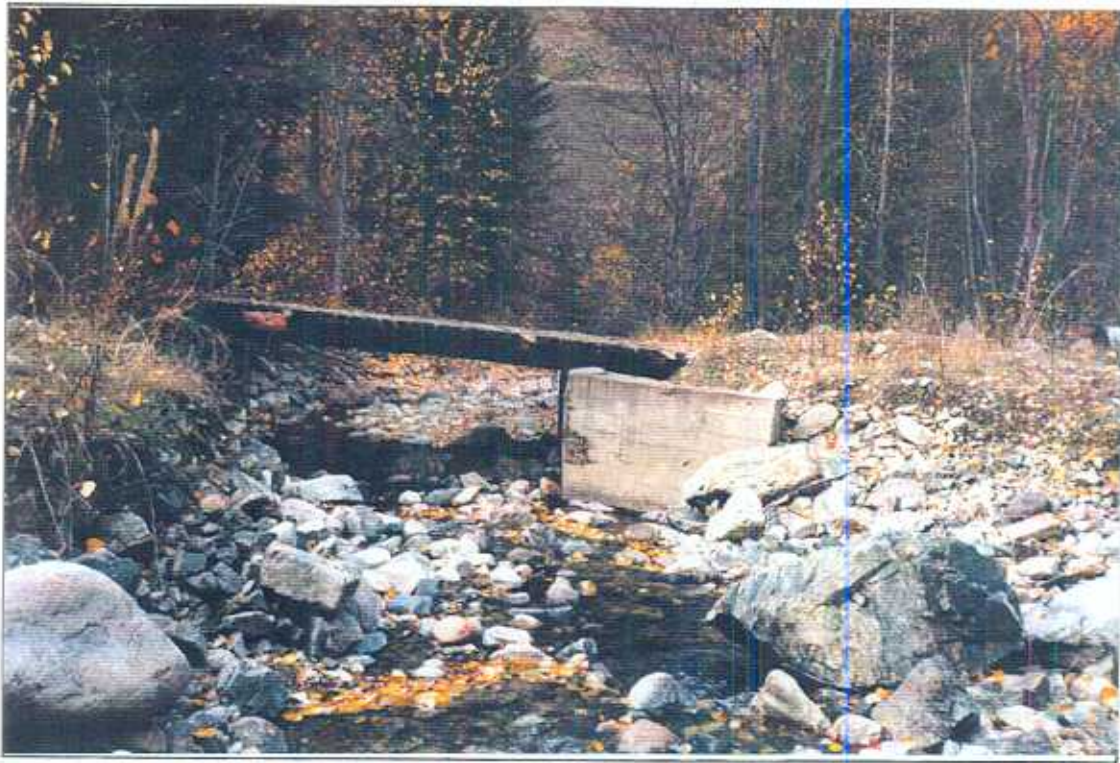
Photo 1. Bridge crossing at the rock quarry with some erosion around the abutments, downstream view.

Code: Q•C•R•3

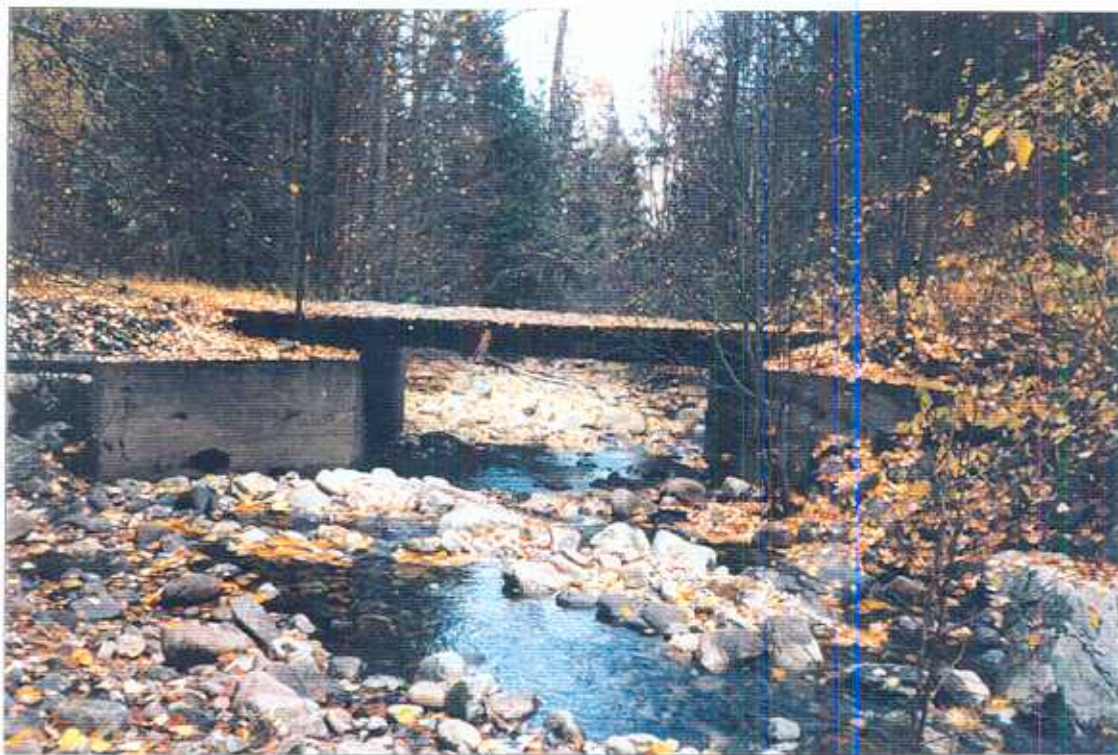
Photo 2. Bridge crossing 100m u/s from rock quarry with some erosion around the abutments, downstream view.

Code: Q•C•R•3

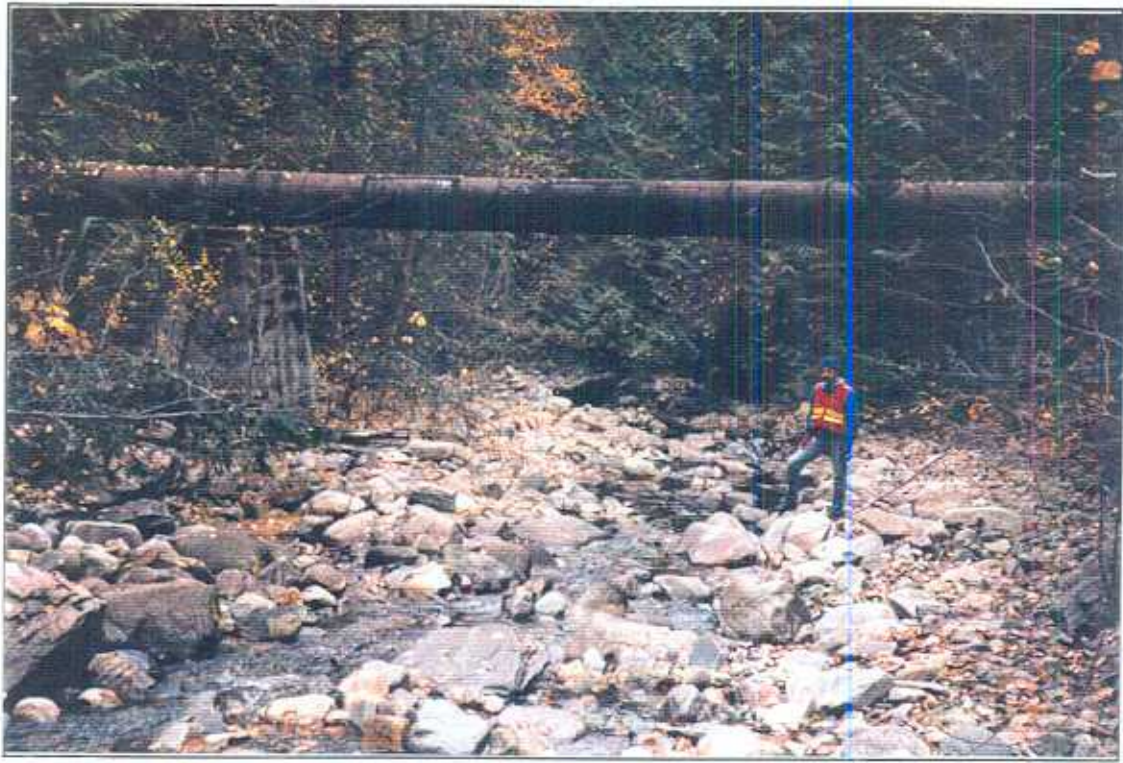
Photo 3. Non-functional water pipe crossing over the channel, downstream view.
Stream Name: Klo Creek **Site #:** 4 **Reach #:** 2
GPS Coordinates: 49°49'56N 119°21'95W **Code:** N/A

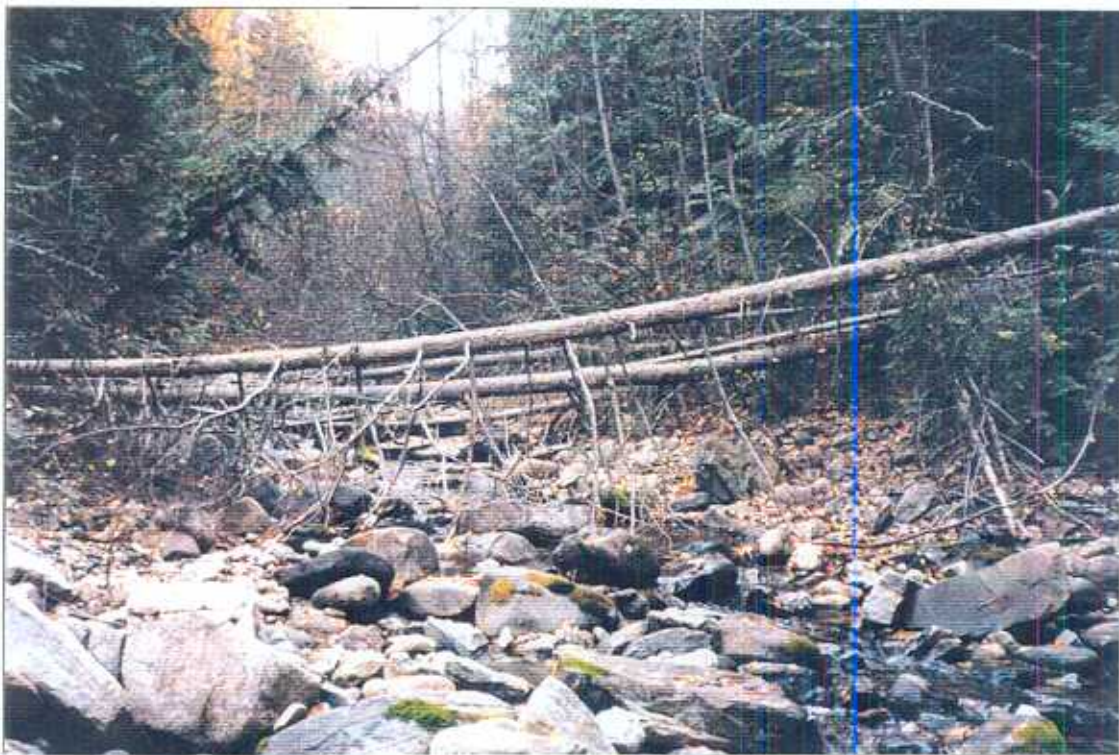
Photo 4. Trees across the channel 20 u/s from the water pipe, upstream view.
Stream Name: Klo Creek **Site #:** 4 **Reach #:** 2
GPS Coordinates: 49°49'56N 119°21'95W **Code:** Fb/Q·D·N·3

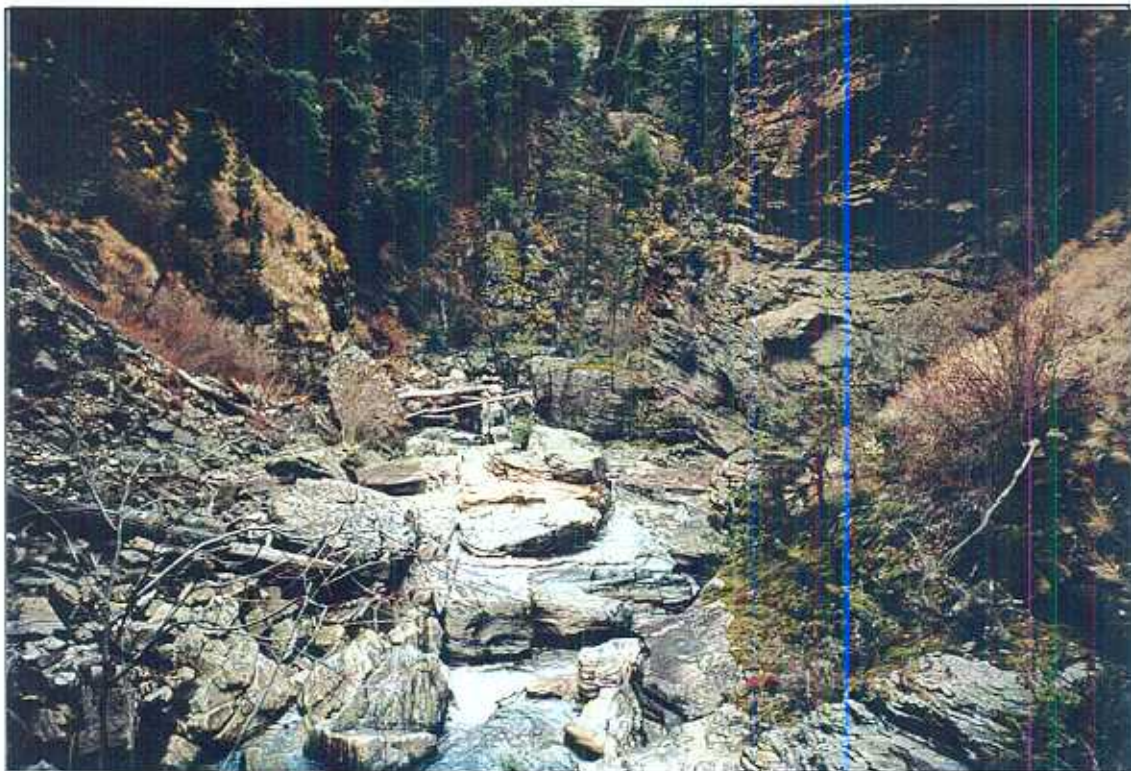
Photo 1. Series of falls/chutes with some natural LWD, downstream view.
Stream Name: Mission Creek **Site #:** 23/24 **Reach #:** 5/6
GPS Coordinates: 49°51'23N 119°18'31W **Code:** Fb•W/D•N/F•1

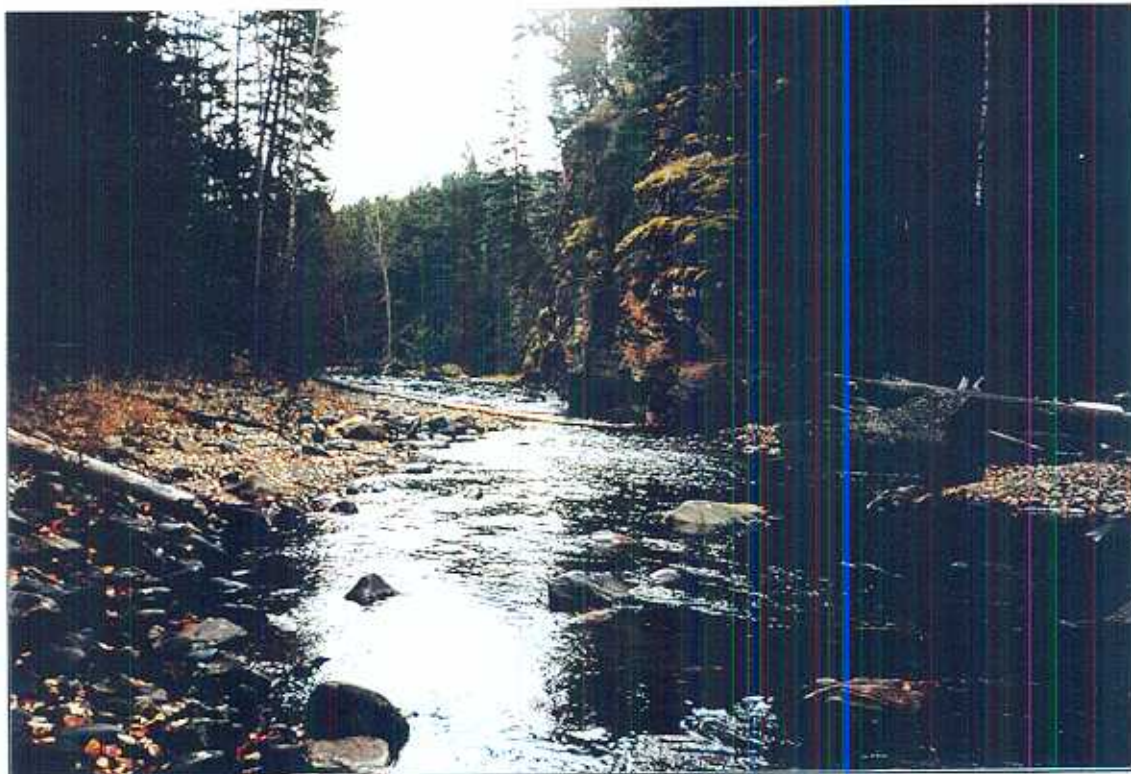
Photo 2. Recently felled trees from a beaver 50m u/s from falls, upstream view.
Stream Name: Mission Creek **Site #:** 23/24 **Reach #:** 5/6
GPS Coordinates: 49°51'23N 119°18'31W **Code:** Fb•W/D•N/F•1

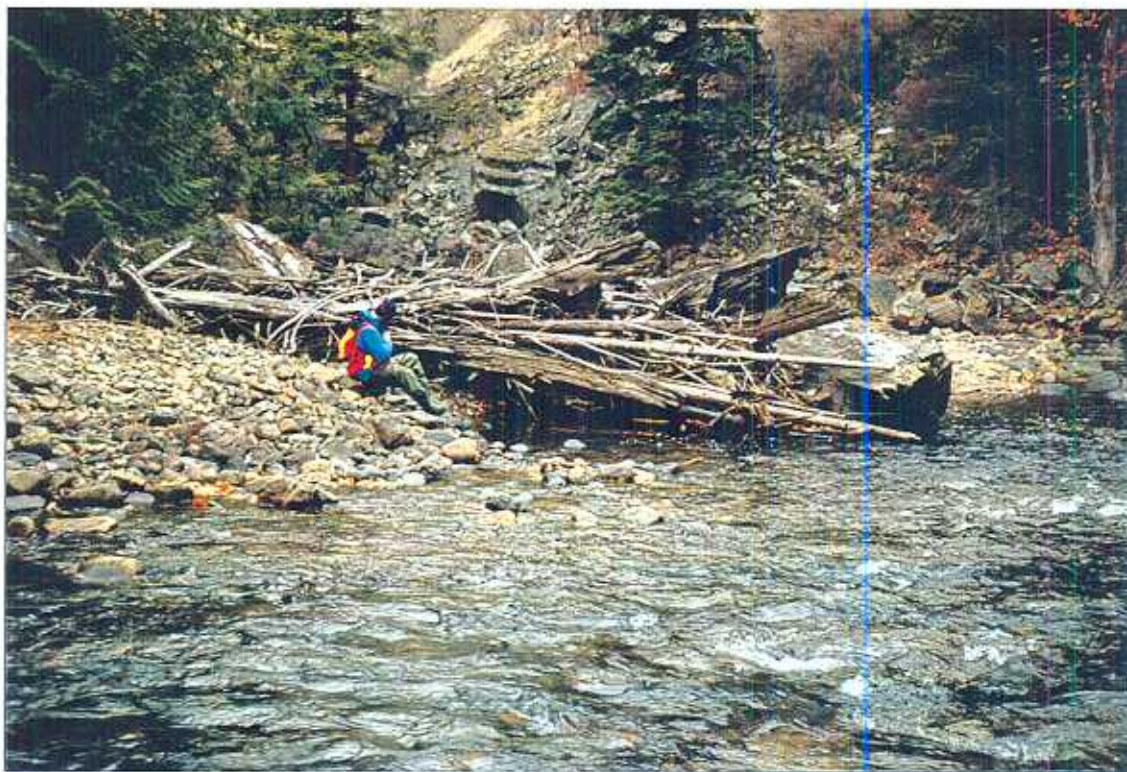
Photo 3. Beaver lodge in an old debris jam 50m u/s from falls, downstream view.
Stream Name: Mission Creek **Site #:** 23/24 **Reach #:** 5/6
GPS Coordinates: 49°51'23N 119°18'31W **Code:** Fb•W/D•N/F•1

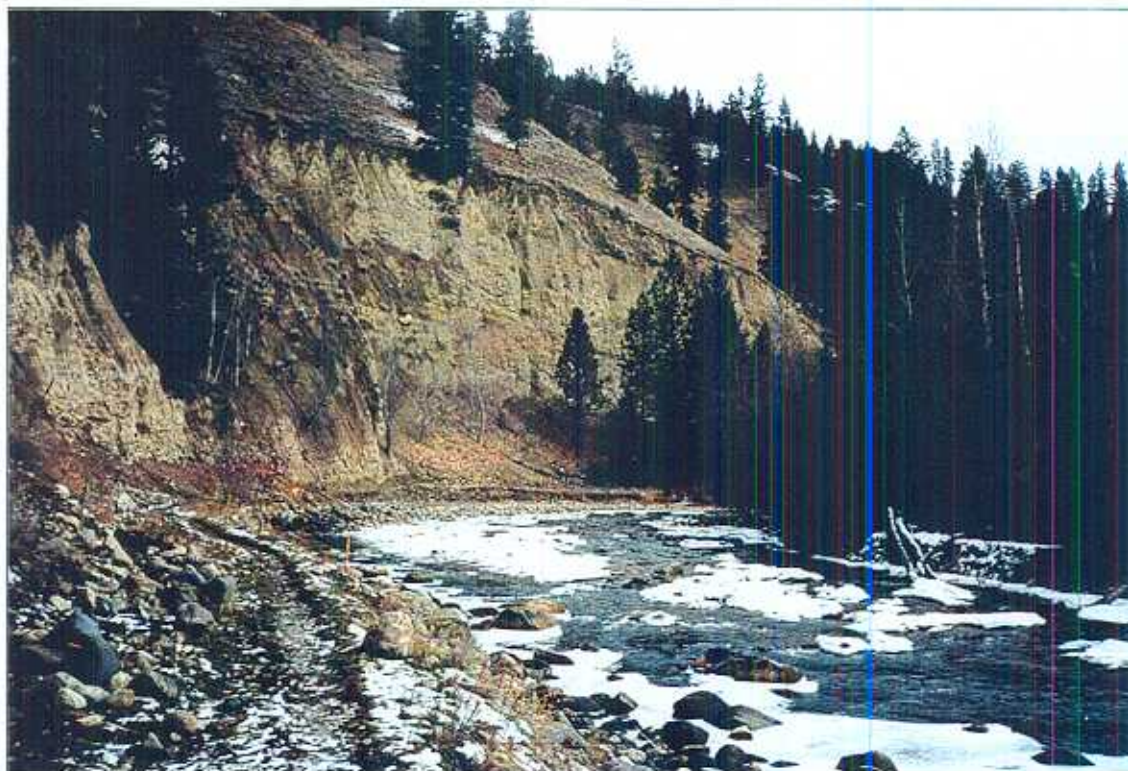
Photo 4. Natural eroding bank on the right bank, upstream view.
Stream Name: Mission Creek **Site #:** 27 **Reach #:** 6
GPS Coordinates: 49°51'47N 119°15'60W **Code:** Fs/Q•S•N•3

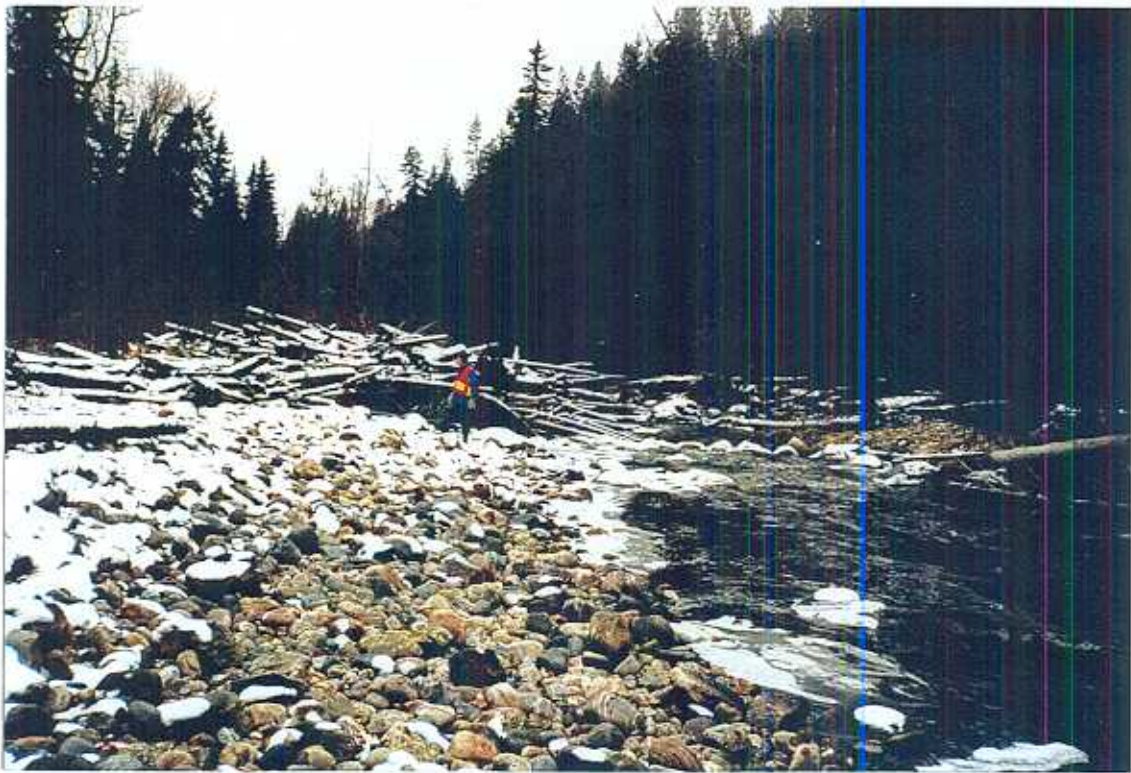
Photo 8. Large debris jam on the left bank, downstream view.
Stream Name: Mission Creek Site #: 29
GPS Coordinates: 49°51'49N 119°14'32W

Reach #: 6
Code: Q•D•N/F•1

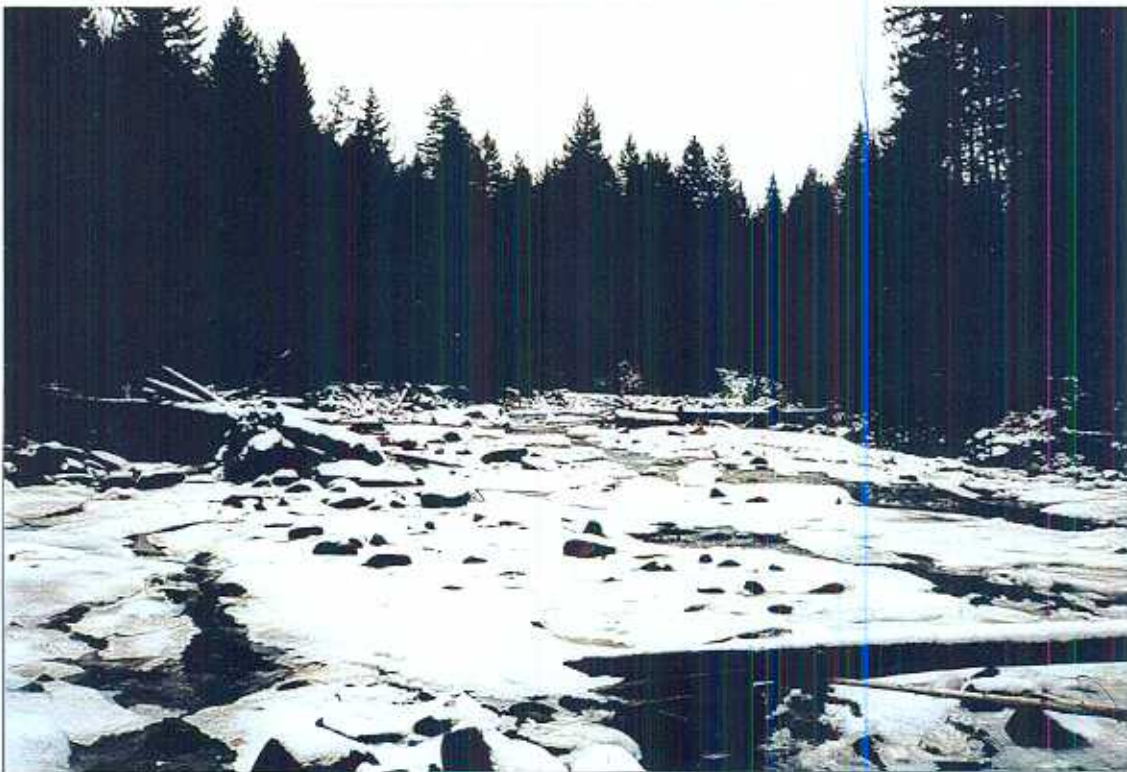
Photo 9. LWD scattered across the channel, upstream view.
Stream Name: Mission Creek Site #: 29
GPS Coordinates: 49°51'56N 119°14'18W

Reach #: 6
Code: Q•D•N/F•1

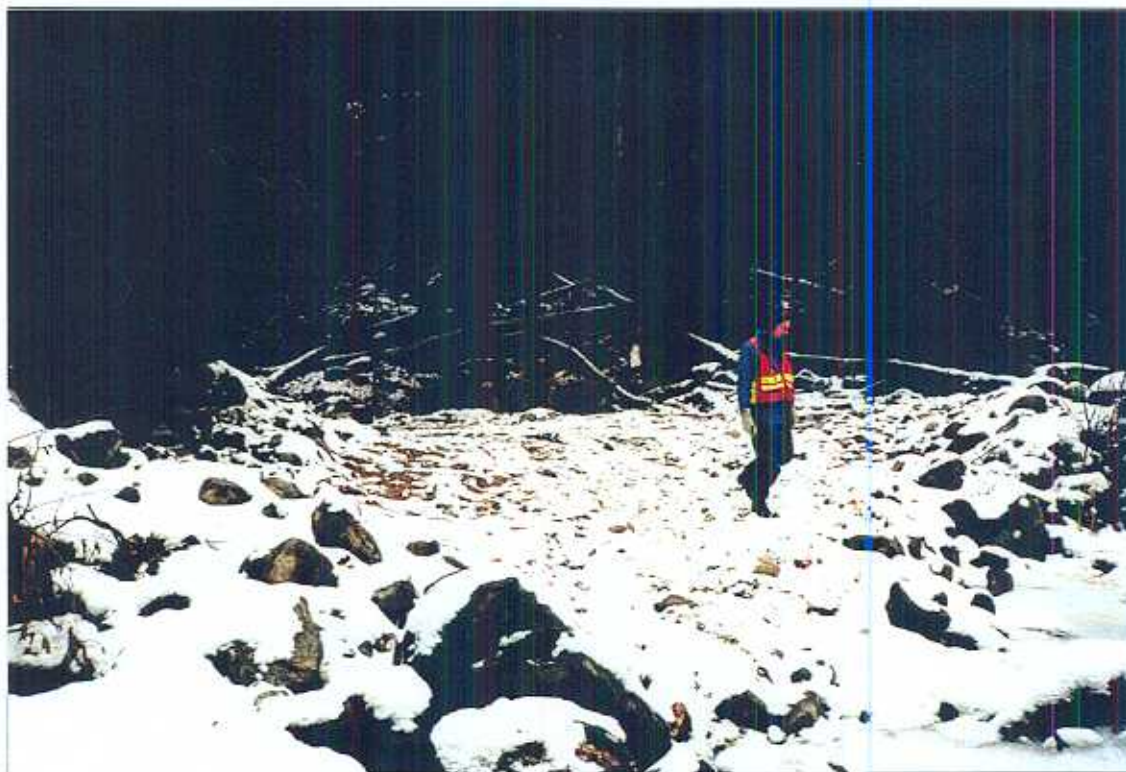
Photo 11. New road on the right bank immediately adjacent to the channel.
Stream Name: Mission Creek **Site #:** 29 **Reach #:** 6
GPS Coordinates: 49°51'56N 119°14'18W **Code:** Q•F•R•1

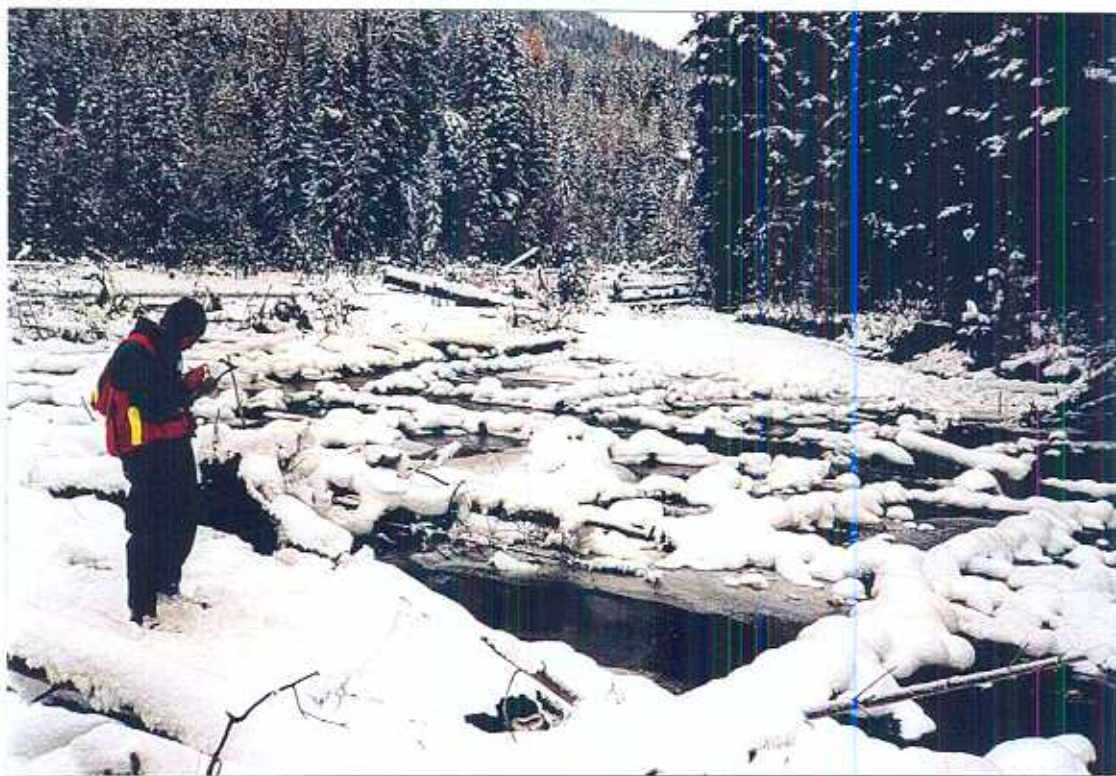
Photo 13. Intricate weir structures spanning the width of the channel, upstream view.
Stream Name: Mission Creek **Site #:** 43 **Reach #:** 7
GPS Coordinates: 49°52'04N 119°06'84W **Code:** Fb•D•R•1

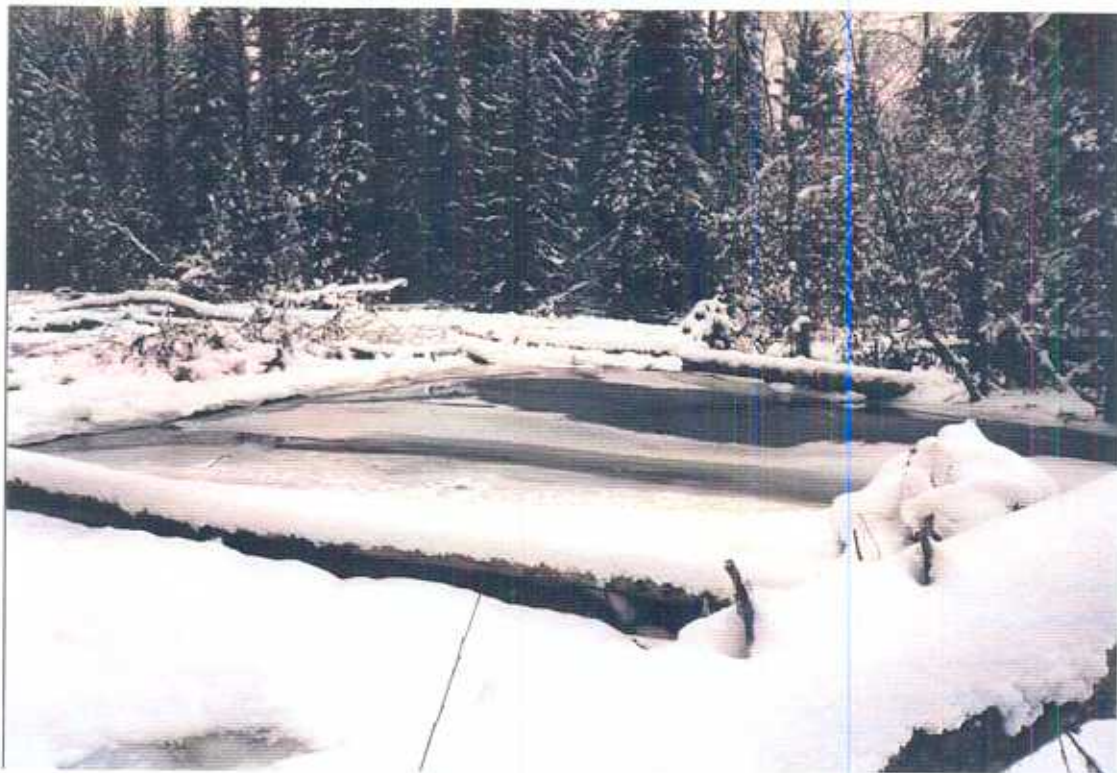
Photo 14. Deep pool and LWD across the channel 20m u/s from weir structures, upstream view.
Stream Name: Mission Creek **Site #:** 43 **Reach #:** 7
GPS Coordinates: 49°52'04N 119°06'84W **Code:** Fb•D•N/F•1

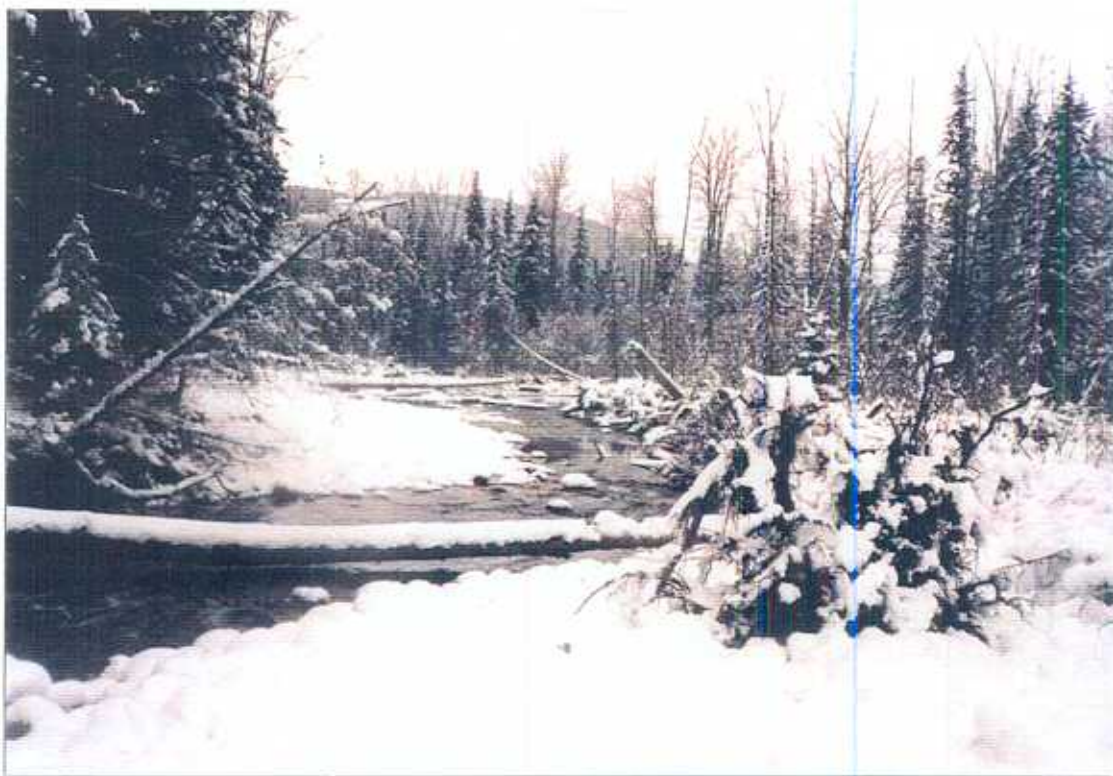
Photo 15. LWD continuing u/s for 300m from weir structures, upstream view.
Stream Name: Mission Creek **Site #:** 43 **Reach #:** 7
GPS Coordinates: 49°52'12N 119°06'75W **Code:** Fb/Q•D•N•2

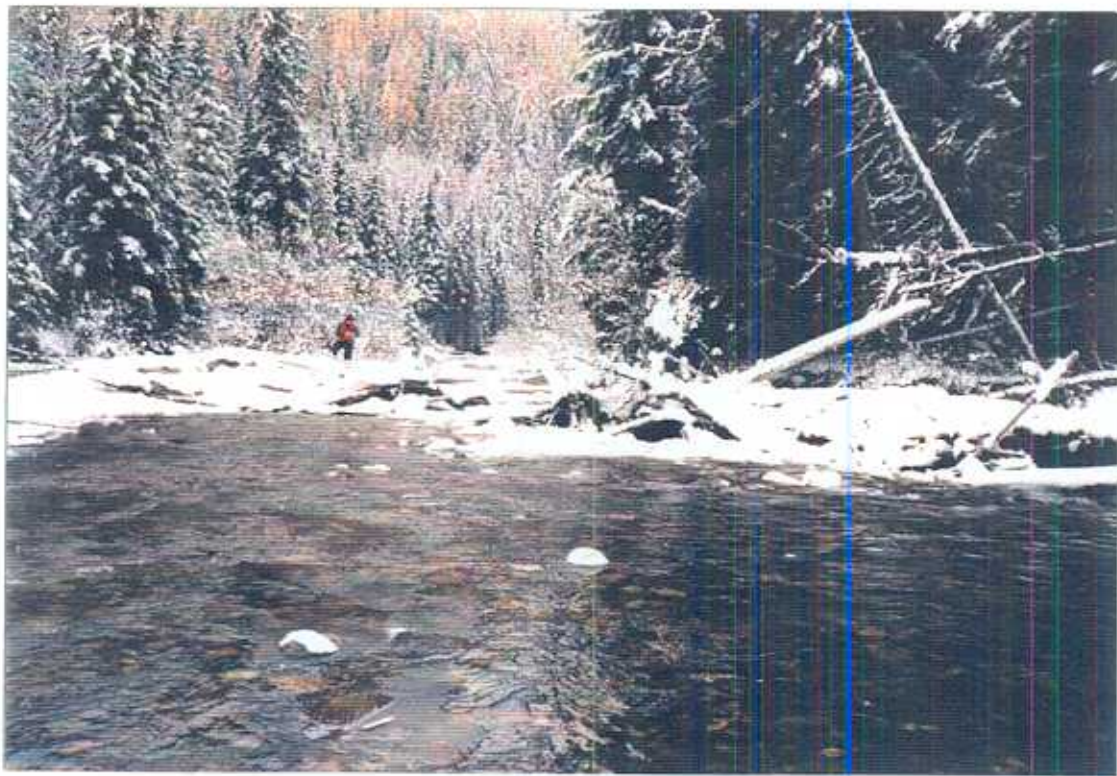
Photo 16. Debris jam blocking a side channel u/s from weir structures, downstream view.
Stream Name: Mission Creek **Site #:** 43 **Reach #:** 7
GPS Coordinates: 49°52'22N 119°05'64W **Code:** Fb•D•N/F•1

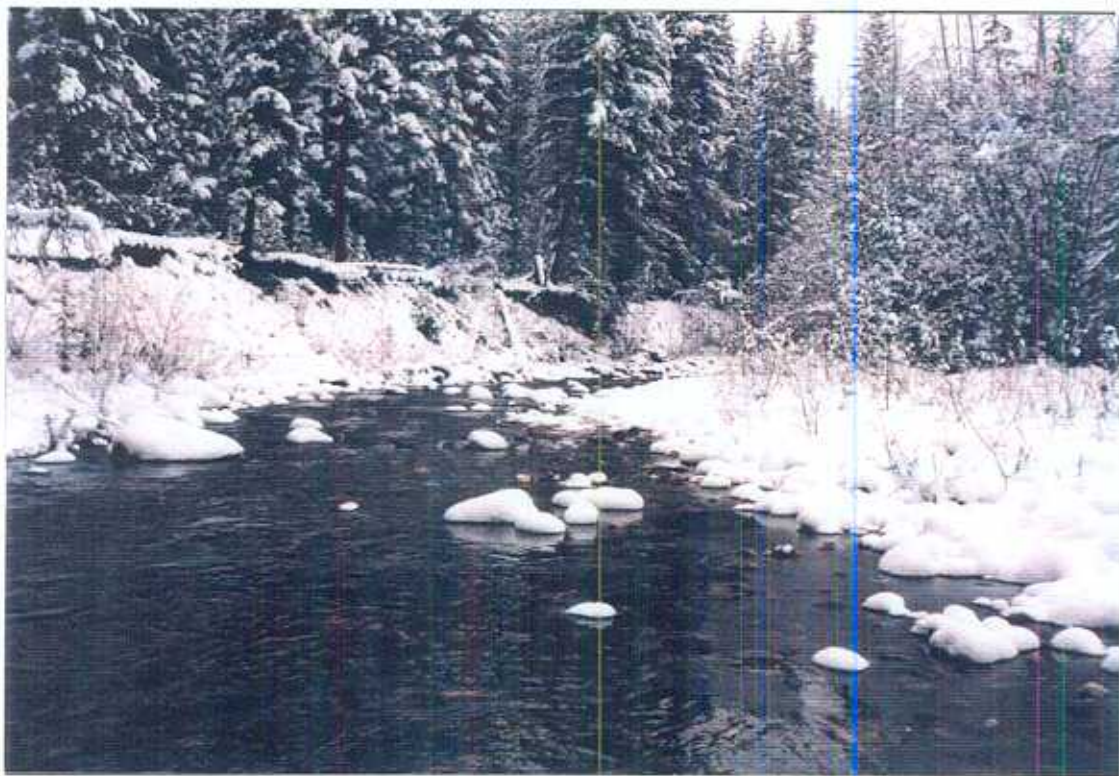
Photo 17. Natural eroding bank 50m u/s from debris jam, upstream view.
Stream Name: Mission Creek **Site #:** 43 **Reach #:** 7
GPS Coordinates: 49°52'22N 119°05'64W **Code:** Q•S•N•3

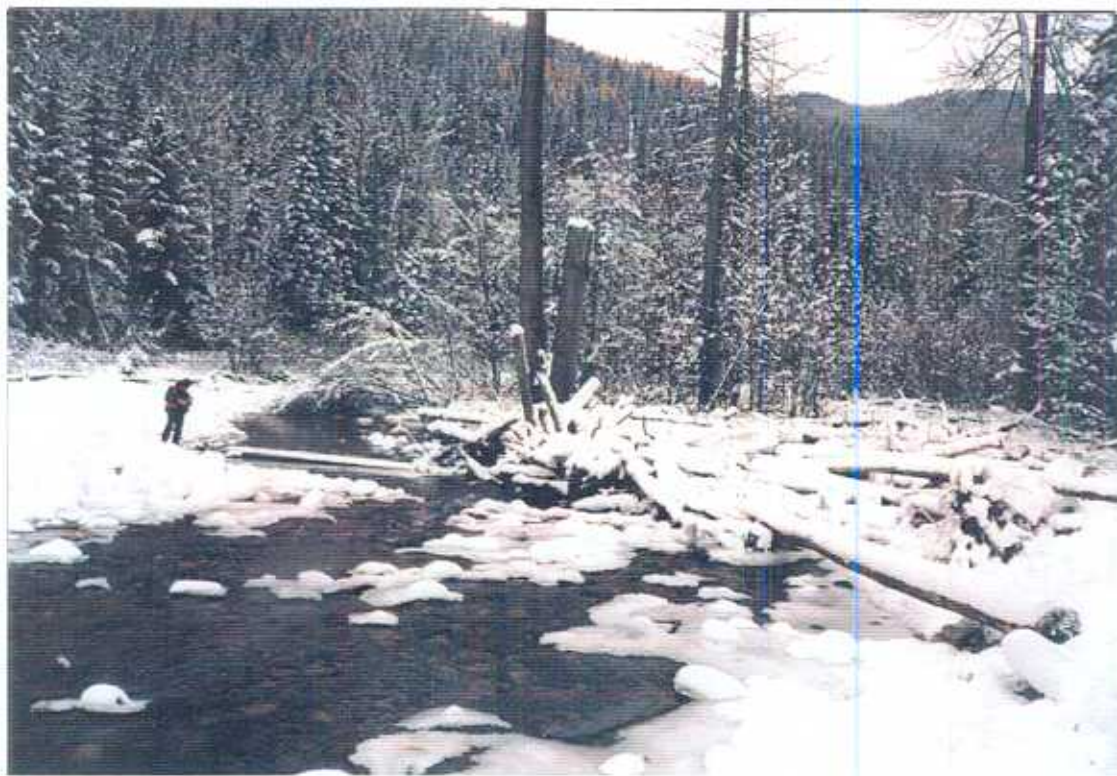
Photo 19. Large debris jam consisting mainly of beaver-cut trees, downstream view.
Stream Name: Mission Creek **Site #:** 45 **Reach #:** 7
GPS Coordinates: 49°52'67N 119°04'54W **Code:** Fb/Q·D·N·1

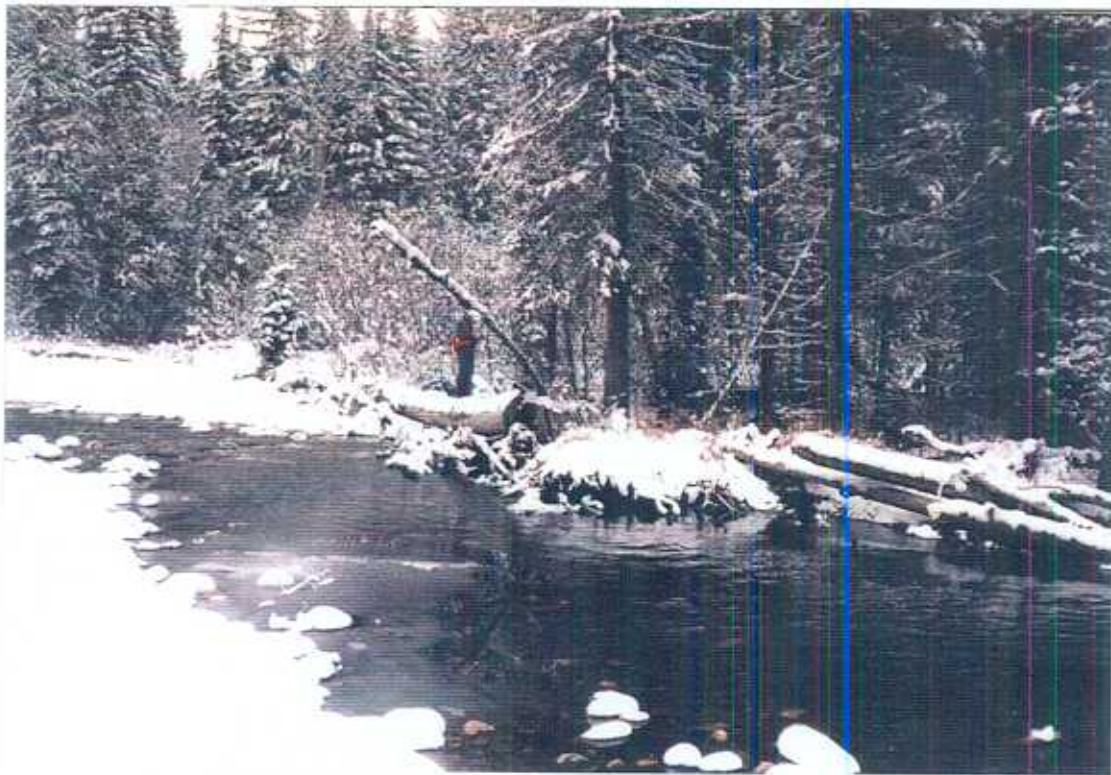
Photo 20. Large diameter tree (1m) cut by beaver and other small debris, upstream view.
Stream Name: Mission Creek **Site #:** 45 **Reach #:** 7
GPS Coordinates: 49°52'70N 119°04'43W **Code:** Q·D·N·2

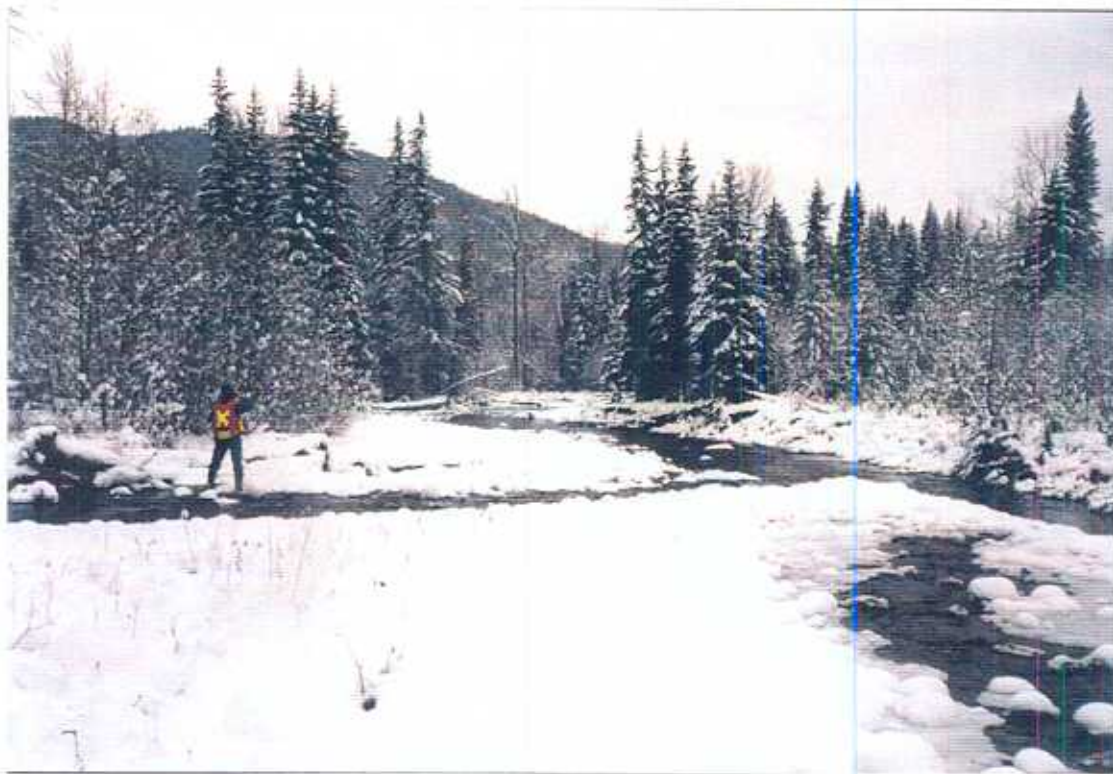
Photo 21. LWD continuing for 200m u/s, upstream view.
Stream Name: Mission Creek **Site #:** 45 **Reach #:** 7
GPS Coordinates: 49°52'70N 119°04'43W **Code:** Fb/Q·D·N·2

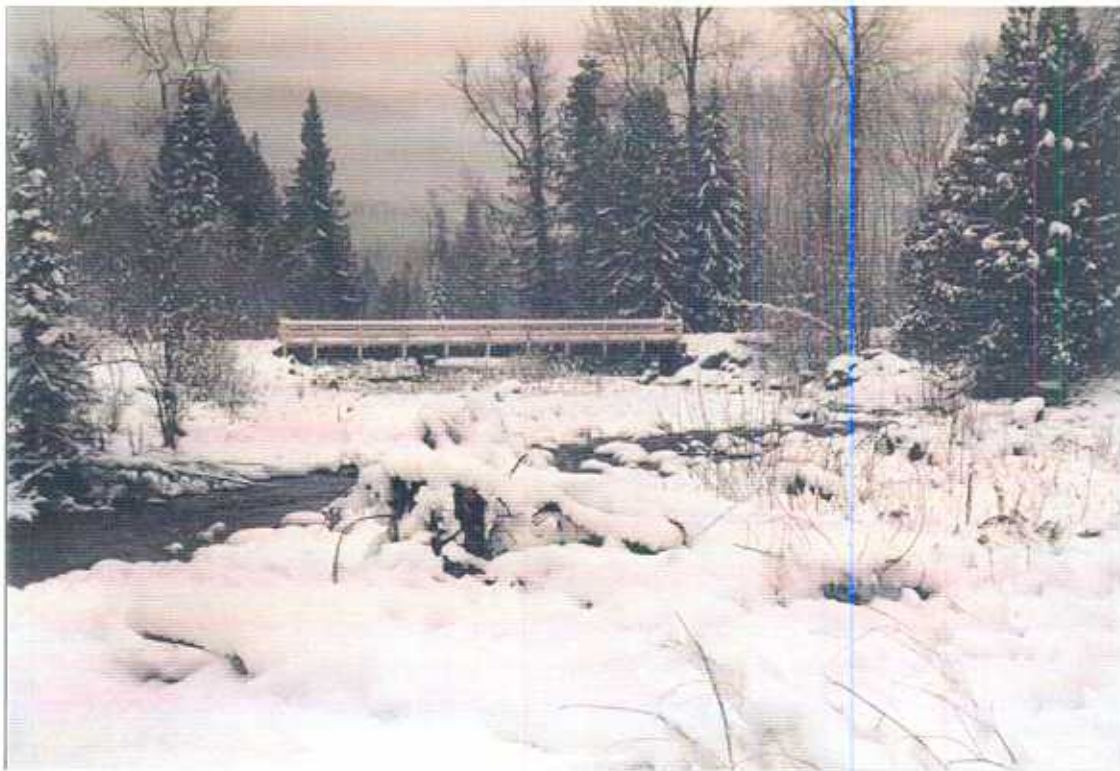
Photo 24. Bridge crossing with some LWD in the channel just u/s, downstream view.
Stream Name: Mission Creek **Site #:** 51 **Reach #:** 7
GPS Coordinates: 49°53'25N 119°03'83W **Code:** Q•D•F•1

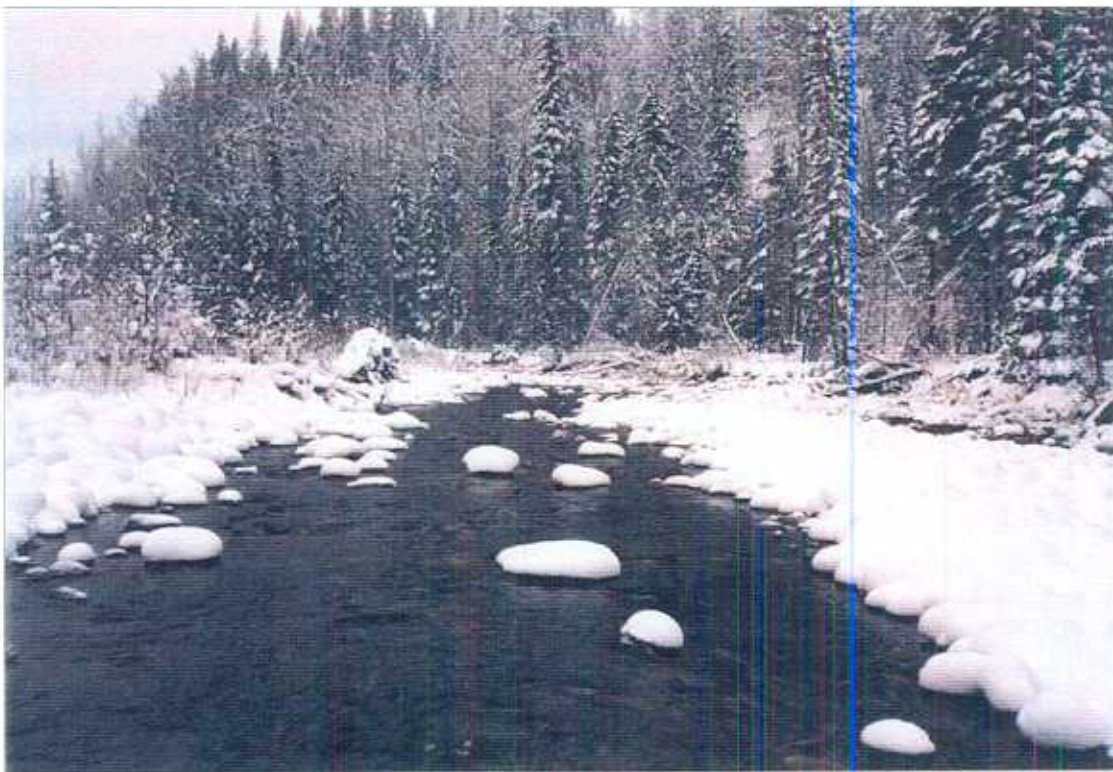
Photo 25. 100m u/s from the bridge, some LWD in the channel with cut-ends, upstream view.
Stream Name: Mission Creek **Site #:** 51 **Reach #:** 7
GPS Coordinates: 49°53'25N 119°03'83W **Code:** Q•D•F•1

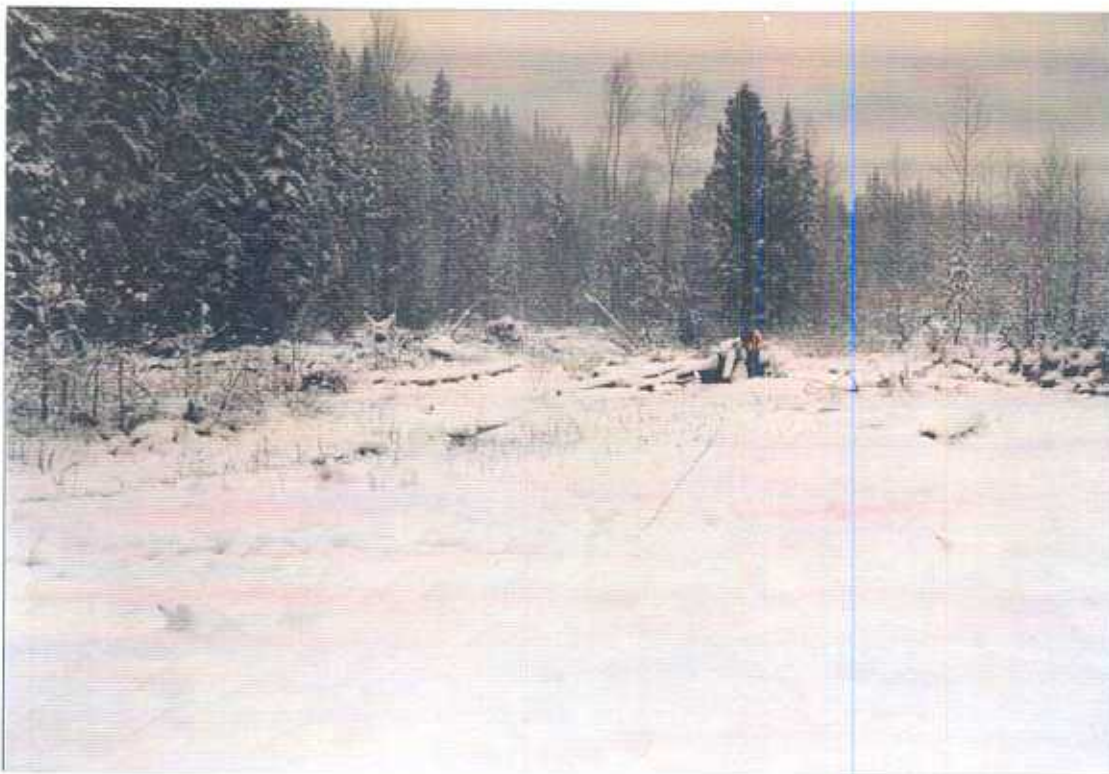
Photo 26. 200m u/s from the bridge, some LWD in the channel, downstream view.
Stream Name: Mission Creek **Site #:** 51 **Reach #:** 7
GPS Coordinates: 49°53'25N 119°03'83W **Code:** Q•D•F•1

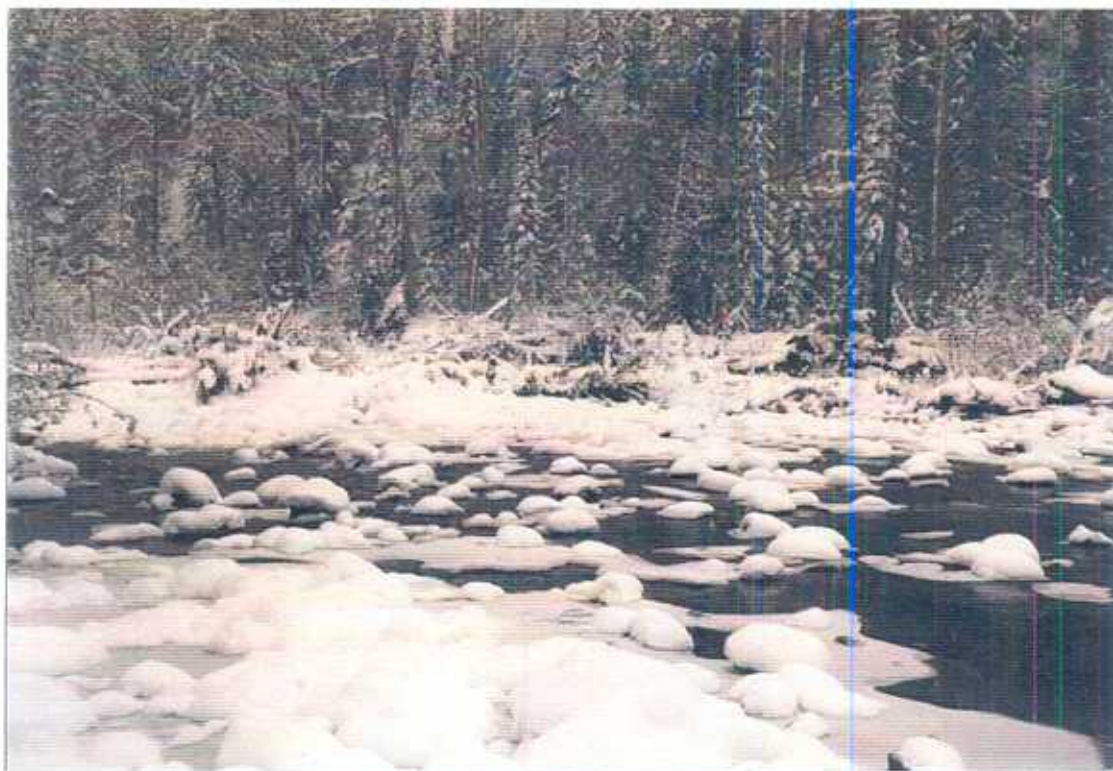
Photo 28. Recently felled trees into the channel on the right bank, downstream view.
Stream Name: Mission Creek **Site #:** 52 **Reach #:** 7
GPS Coordinates: 49°53'52N 119°03'64W **Code:** Q·D·F·1

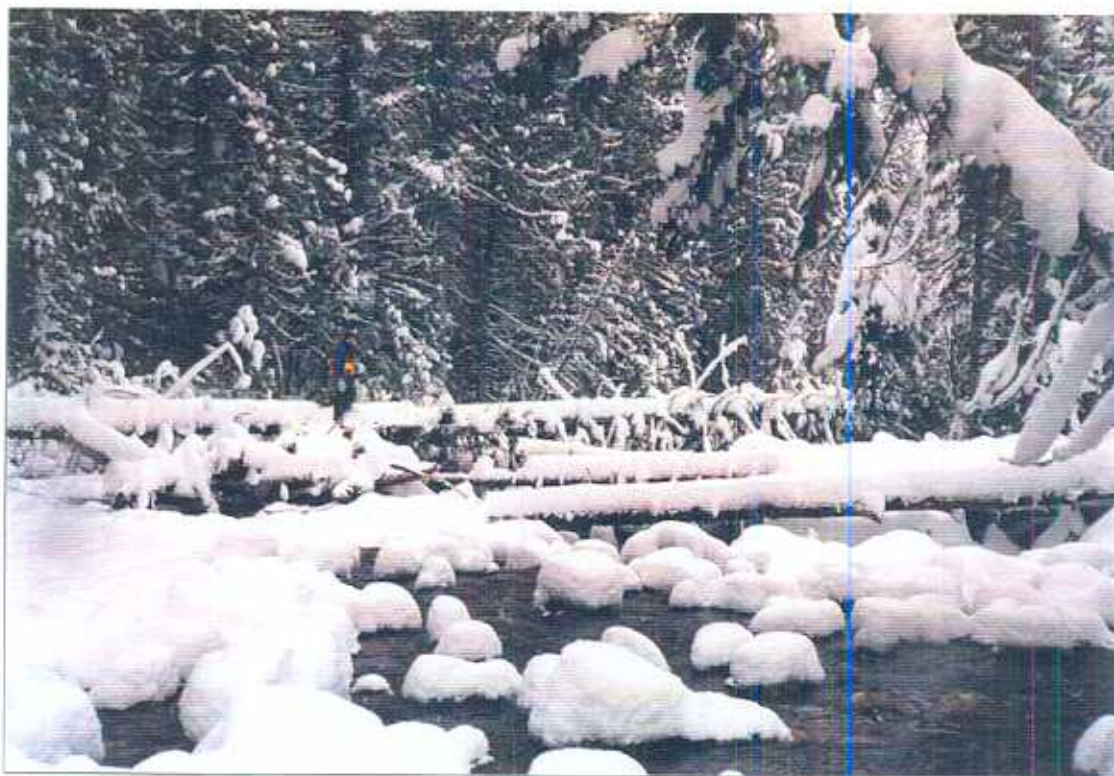
Photo 30. Natural debris jam (stable) caused by a beaver, upstream view.
Stream Name: Mission Creek **Site #:** 56 **Reach #:** 8
GPS Coordinates: 49°56'94N 119°02'56W **Code:** Fb/Q•D•N•3

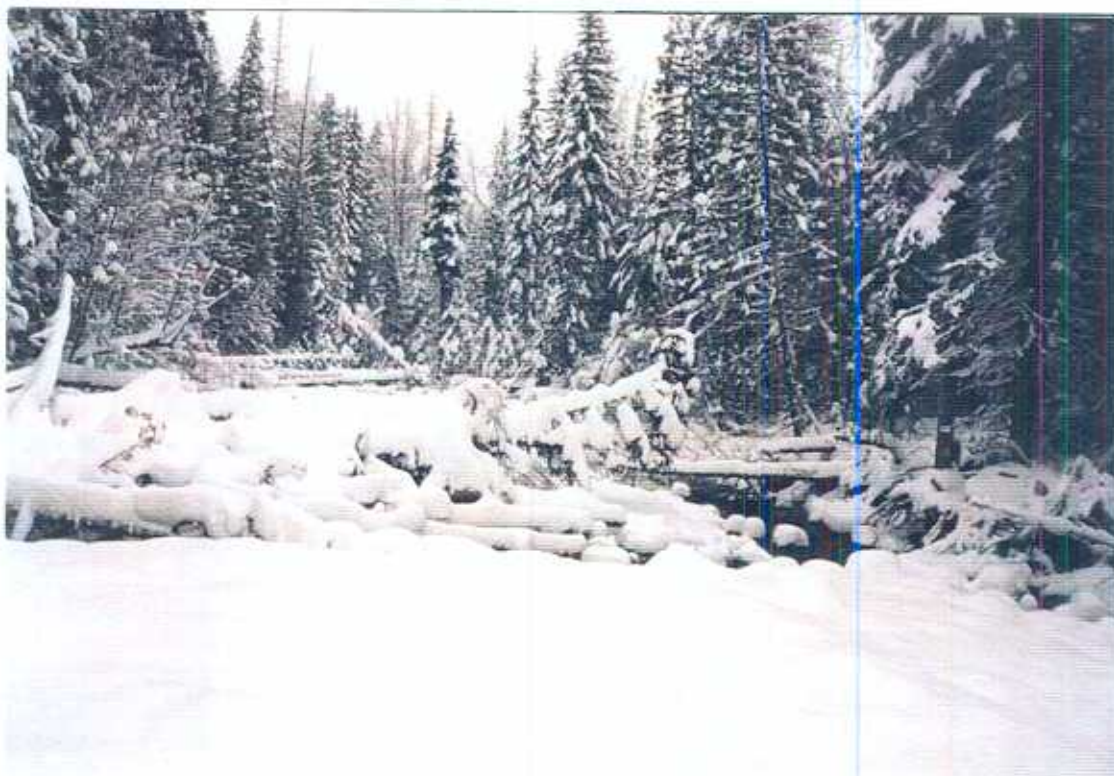
Photo 31. LWD (natural) on the gravel bars, upstream view.
Stream Name: Mission Creek **Site #:** 56 **Reach #:** 8
GPS Coordinates: 49°56'94N 119°02'56W **Code:** Fb/Q•D•N•3
