Interim Report

WATERSHED RESTORATION PROGRAM

MISSION CREEK STREAM ASSESSMENT

Project 511.01

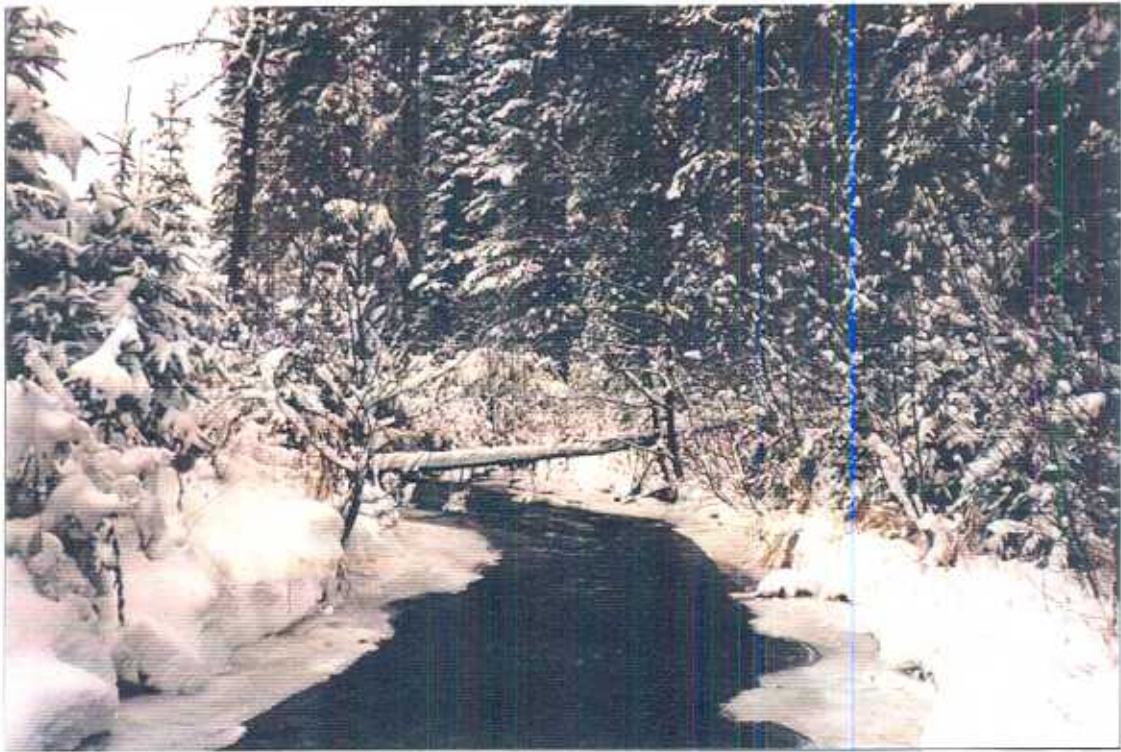
Photo 5. Just d/s from the SE block boundary, 757m u/s from the SW block boundary, downstream view.

Stream Name: Hydraulic Creek **Site #:** 15/16 **Reach #:** 4
GPS Coordinates: 49°48'08N 119°12'52W **Code:** N/A

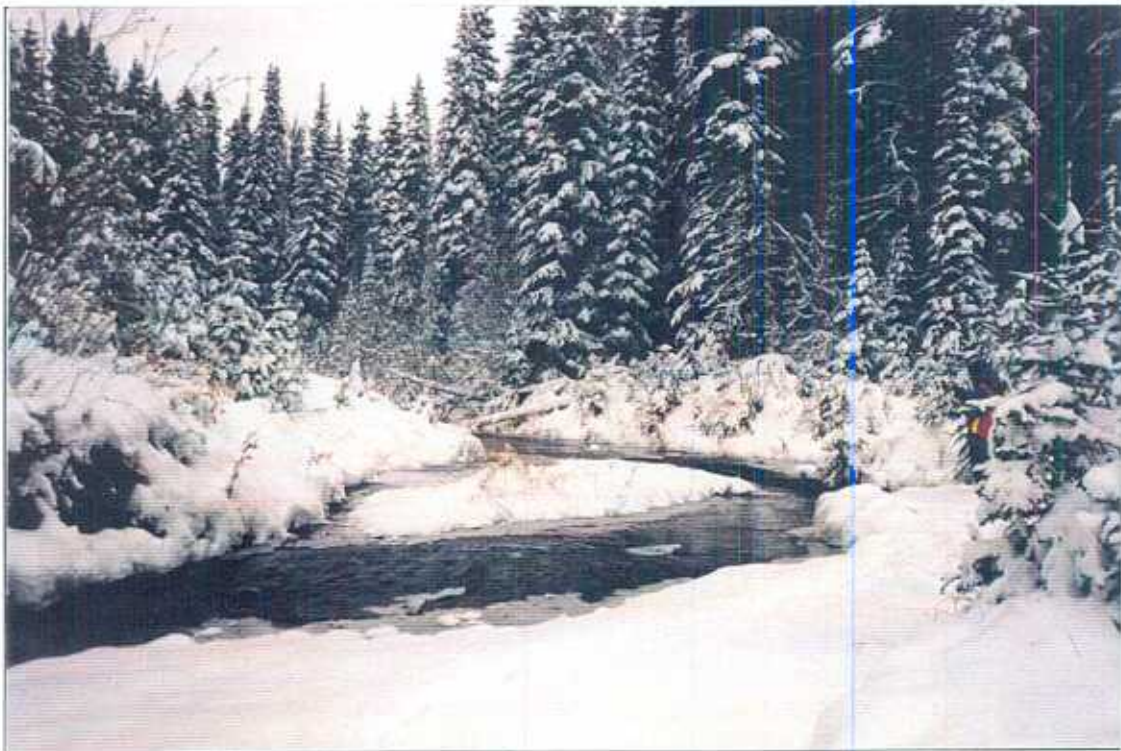
Photo 6. Just u/s from the SE block boundary, upstream view.

Stream Name: Hydraulic Creek **Site #:** 15/16 **Reach #:** 4
GPS Coordinates: 49°48'08N 119°12'52W **Code:** N/A

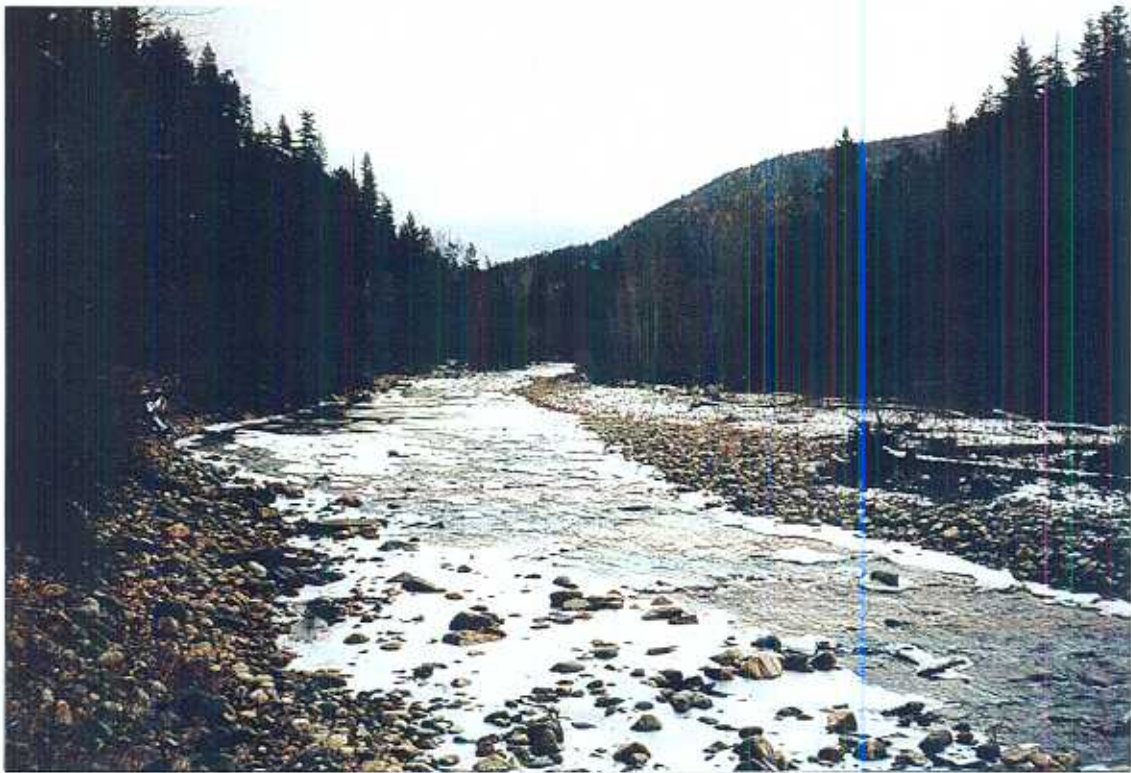
Natural features of this site include a 30-50 m high actively eroding bank on the right side of the stream. Conditions of the site at the time of the survey are shown in Photos 4-7 in Appendix G. This site was initially given an Fb/Q•S•N•3 code but the code was revised to Q•S•N•3 in the field. This site was surveyed at the recommendation of Mr. Malcolm Campbell of Black Mountain Irrigation District. Photo 6 shows a small debris jam on the left bank of the stream 50 m upstream from the eroding bank.

Photo 5. 50m u/s from natural eroding bank on the right bank, upstream view.
Stream Name: Mission Creek Site #: 27 Reach #: 6
GPS Coordinates: 49°51'47N 119°15'60W Code: Fs/Q•S•N•3

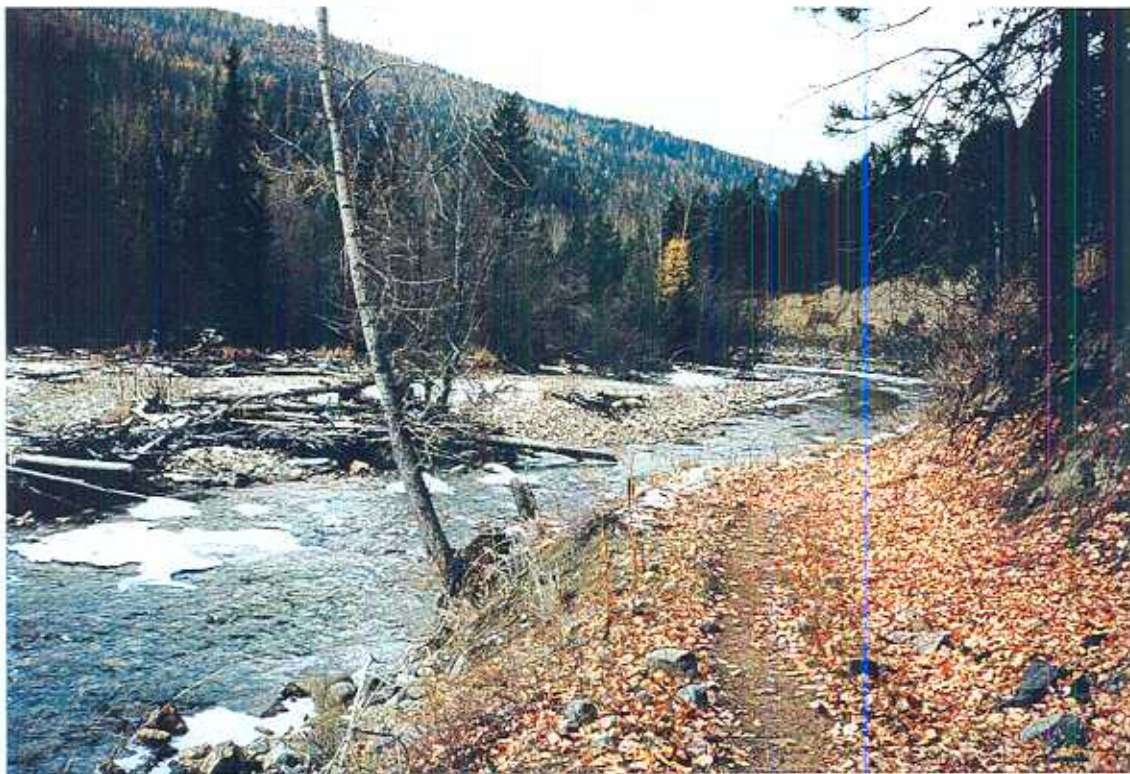
Photo 6. 50m u/s from natural eroding bank, debris on the left bank, downstream view.
Stream Name: Mission Creek Site #: 27 Reach #: 6
GPS Coordinates: 49°51'47N 119°15'60W Code: Fs/Q•S•N•3

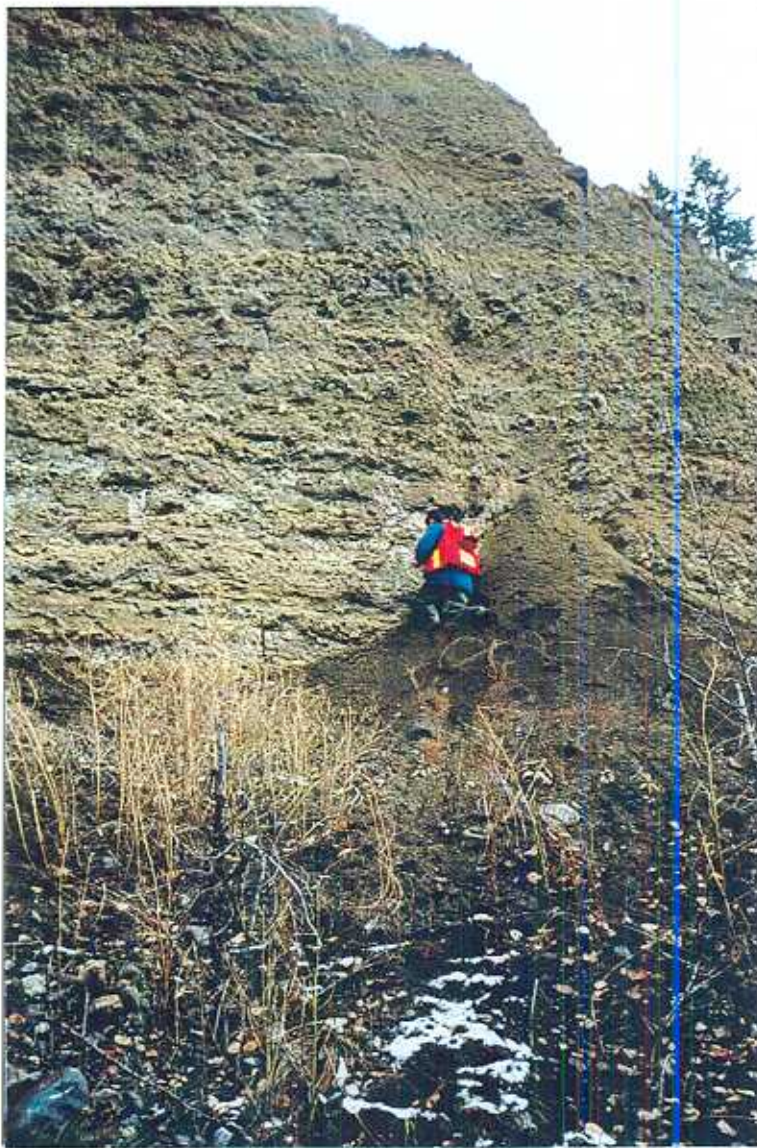
Photo 7.

Natural eroding bank with active slumping 5m from the channel.

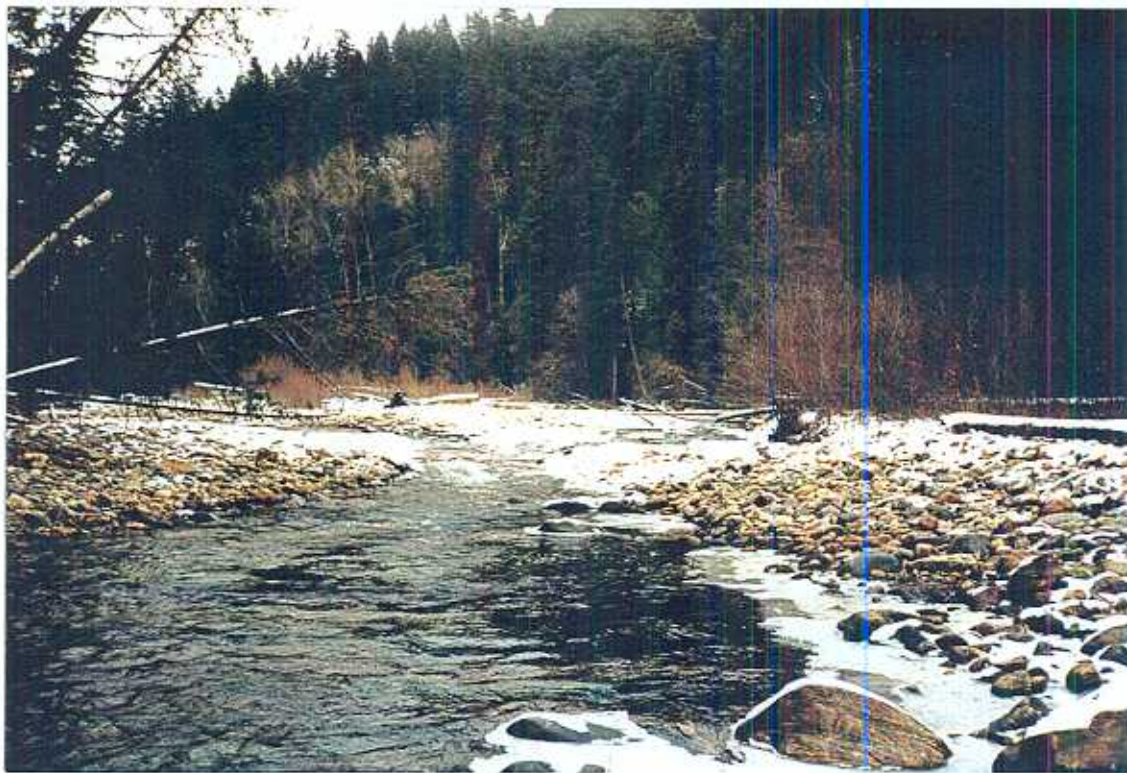
At Site #29 the stream has a low gradient and is relatively wide with coarse substrate material (Photos 8-12, Appendix G). This site was initially given an Fb•D•F•1 code but as a result of the field check the code was revised to Q•D•N/F•1. Photo 8 shows a large debris jam on the left bank which has the potential to travel further downstream during high flows. The majority of the debris consists of trees with root-wads and beaver-cut trees, however there are several pieces of LWD with cut ends and some milled timbers (6"x10"x6'). LWD at this site is scattered throughout the channel for a distance of 500 m (Photo 9), the majority being natural in origin. Two domestic water wells/pump houses are within 50 m of the channel (Photo 12) and the accompanying road ends at the right stream bank (Photo 11). The road is a potential source of sediment to the stream.

Photo 10. Braided stream channel u/s from the debris, upstream view.
Stream Name: Mission Creek **Site #:** 29 **Reach #:** 6
GPS Coordinates: 49°51'49N 119°14'32W **Code:** N/A

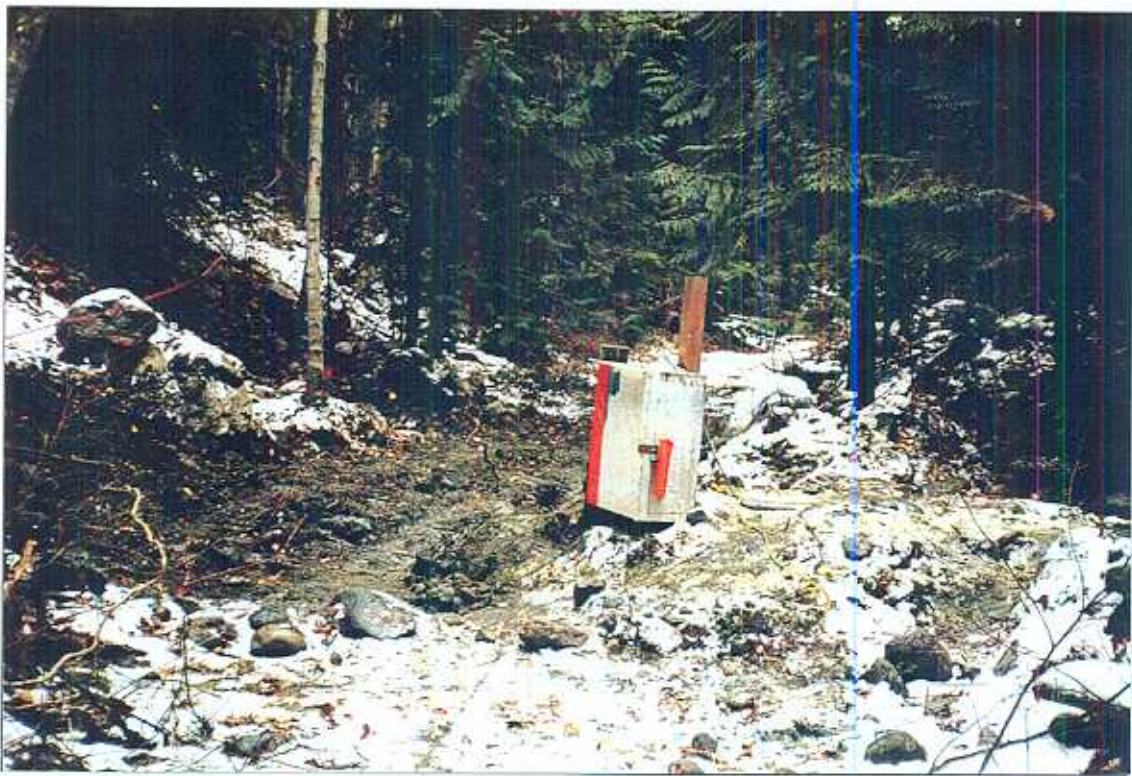
Photo 12. New road and domestic water well on the right bank 50m from the channel.
Stream Name: Mission Creek **Site #:** 29 **Reach #:** 6
GPS Coordinates: 49°51'56N 119°14'18W **Code:** N/A

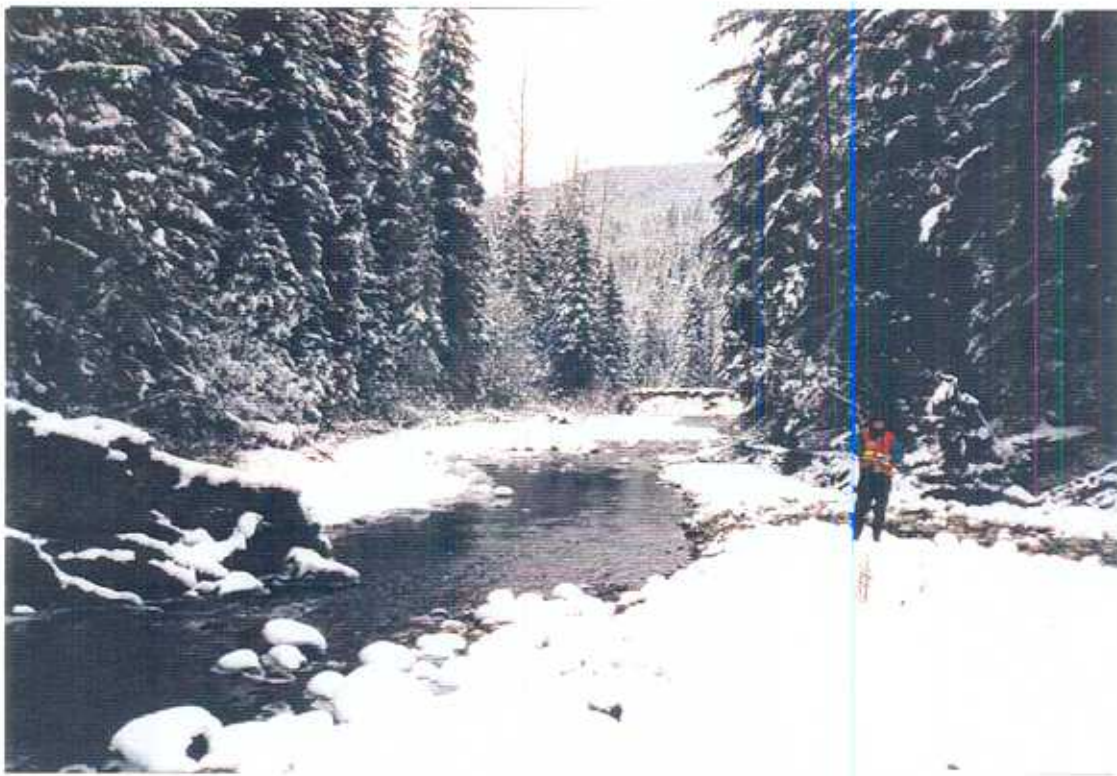
Photo 18. Deep pool 300m d/s from weir structures, downstream view.
Stream Name: Mission Creek **Site #:** 43 **Reach #:** 7
GPS Coordinates: 49°51'97N 119°06'92W **Code:** N/A

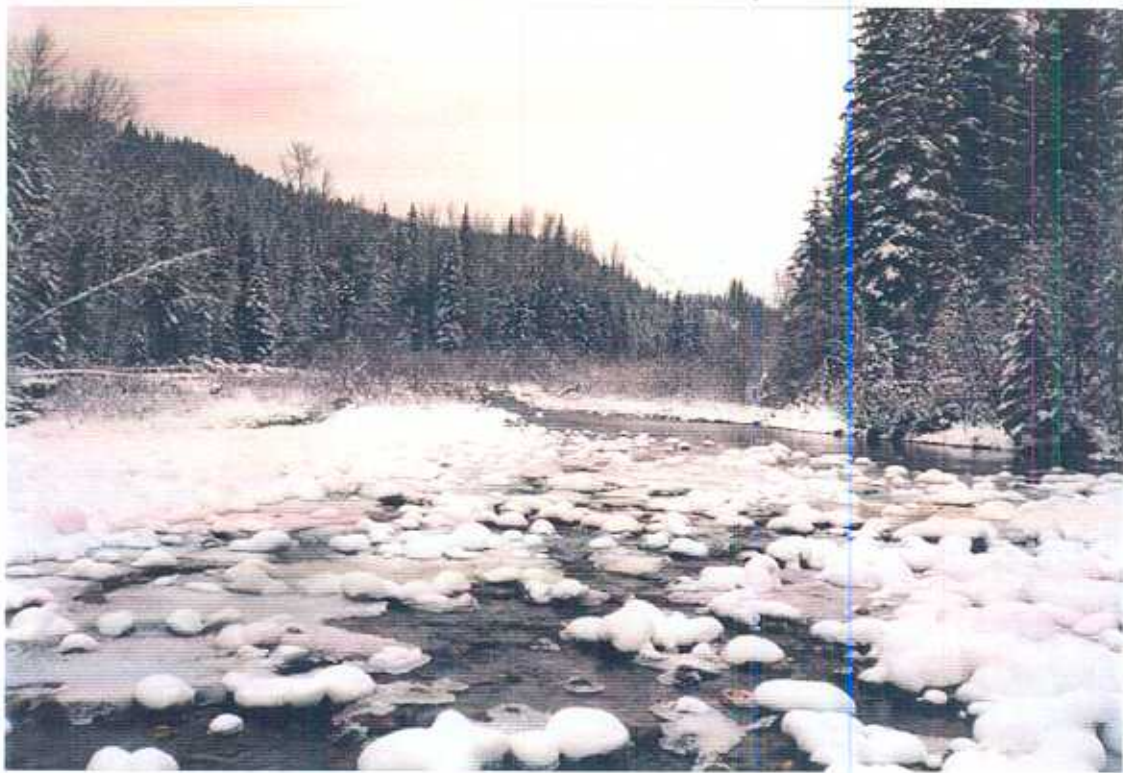
This site is similar to site #43 (Photos 19-23, Appendix G). Initially classed as Q•D•F•1 from the helicopter survey, the code was revised to Fb/Q•D•N•1 in the field. A large debris jam (approx. 30 m x 4 m x 1 m) is blocking a secondary channel along the right bank flowing around a vegetated island that is approximately 6 m wide (Photo 19). Most of the debris consists of beaver-cut or uprooted trees, and some of the longer pieces extending over the channel have been cut. Similar to site #43, most of the debris appears stable but the site could be enhanced by selective removal or by anchoring some of the pieces. LWD scattered across the channel continues upstream for 200 m (Photo 21). There are several large pools at this site, they are controlled by downstream accumulations of gravel (Photos 22, 23).

Photo 22. Large pool (10m x 20m x 0.5m), upstream view.
Stream Name: Mission Creek **Site #:** 45
GPS Coordinates: 49°52'70N 119°04'43W

Reach #: 7
Code: N/A

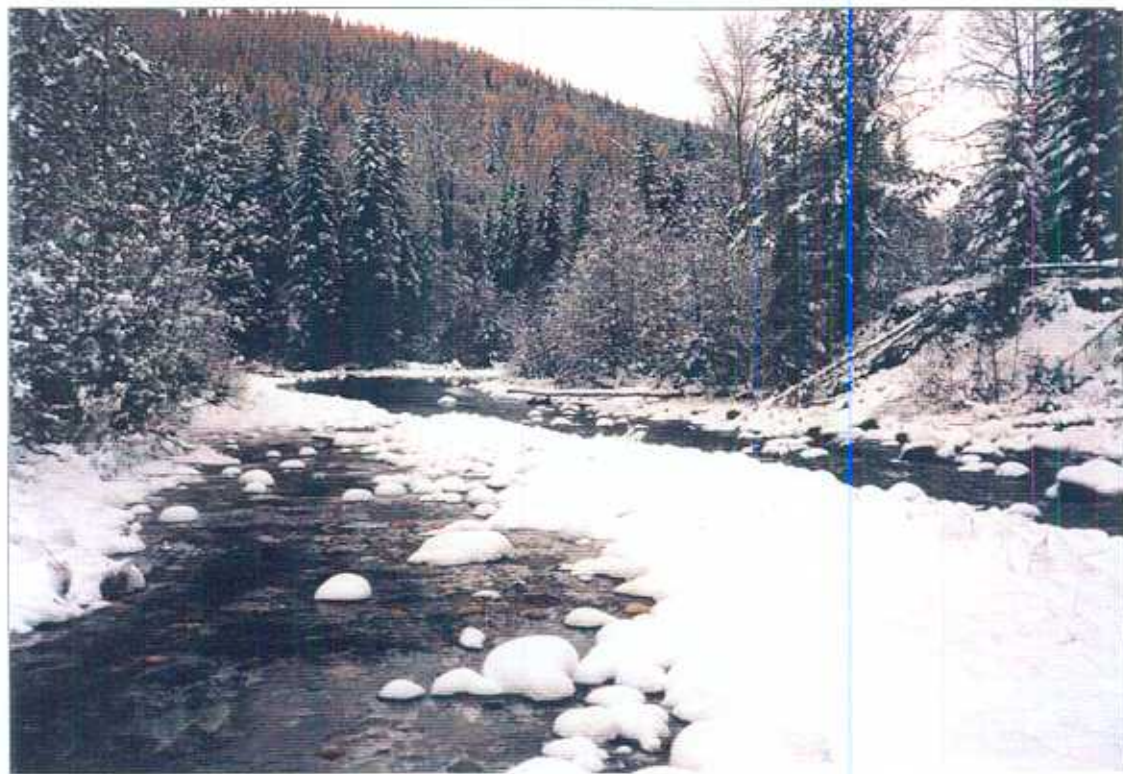
Photo 23. Large pool (15m x 30m x 1m) controlled by a gravel bar, downstream view.
Stream Name: Mission Creek **Site #:** 45
GPS Coordinates: 49°52'39N 119°05'69W

Reach #: 7
Code: N/A

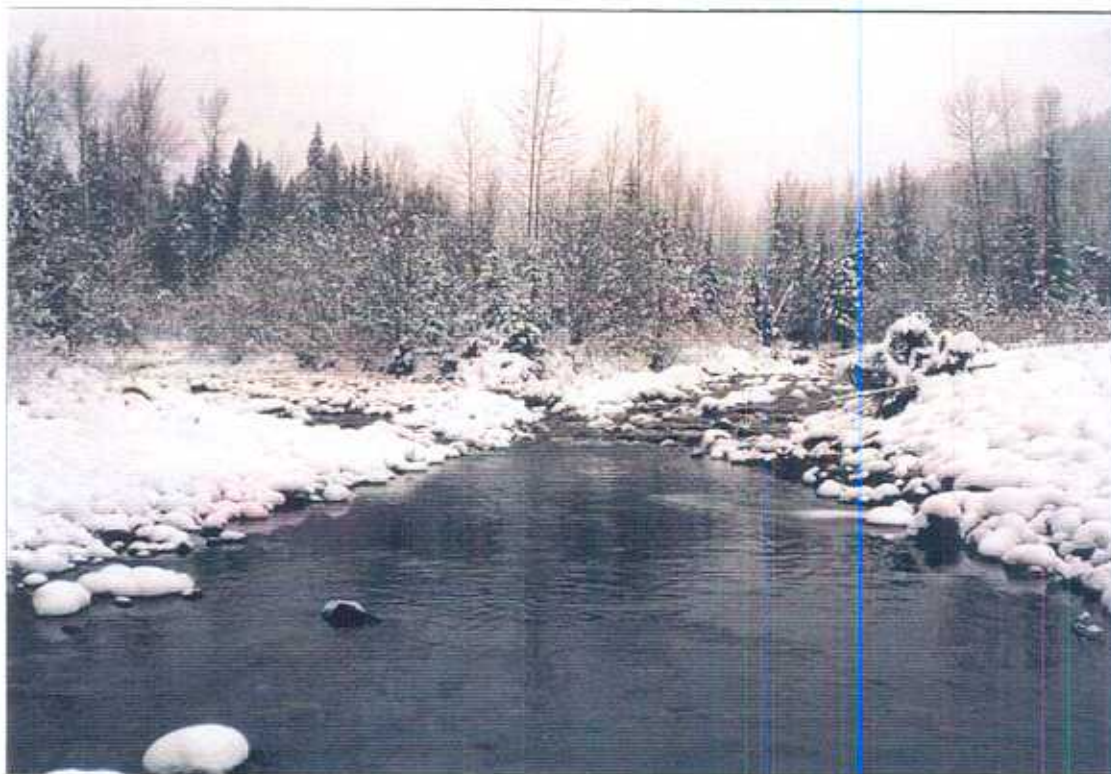
This site is similar to the other Reach 7 sites (Photos 27-29 Appendix G). Initially given an Fb/Q•D•F•1 code, the field check resulted in the fish barrier (Fb) code being removed as a potential problem. Logging has recently taken place (probably 1994) within 10 m of the stream. Photo #28 shows recently felled trees on the right bank, some of which were felled directly into the channel. Historically the floodplain has been selectively logged on both sides of the stream and many large diameter stumps still remain. Some of these stumps have been transported into the channel from the eroding, undercut banks. As with site #51, the debris could be transported downstream and impact the bridge.

Photo 27. 200m d/s from felled trees the two secondary channels join, upstream view.
Stream Name: Mission Creek **Site #:** 52 **Reach #:** 7
GPS Coordinates: 49°53'52N 119°03'64W **Code:** N/A

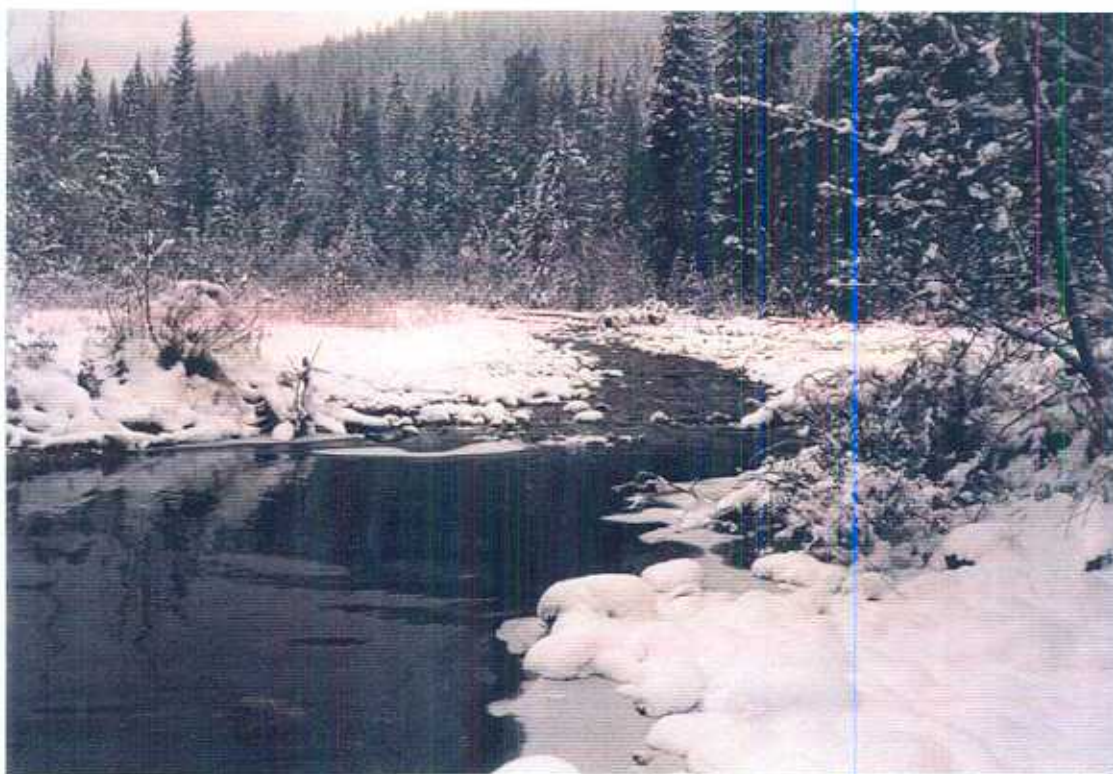
Photo 29. Just u/s from recently felled trees into the channel on the right bank, upstream view.
Stream Name: Mission Creek **Site #:** 52 **Reach #:** 7
GPS Coordinates: 49°53'52N 119°03'64W **Code:** N/A

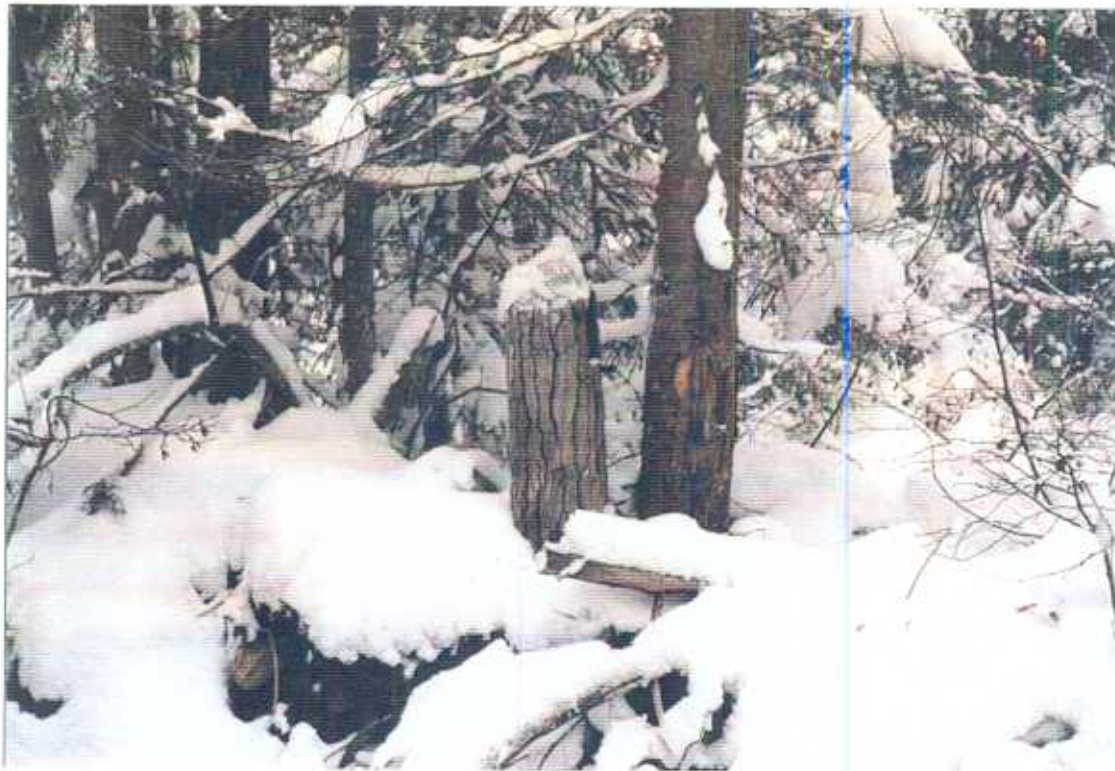
Photo 32.

consists of beaver-cut trees and other natural LWD. This debris jam would only constrict the flow of the stream, and become unstable, at peak water levels because it is currently stranded on a gravel bar 2-3 m above the thalweg of the channel. There is recent evidence of beaver-cut trees 100 m upstream from the debris jam (Photo 32).

Beaver-cut tree stumps.
